**Building Assessment Studies and Cost Estimates**  
for  
**Capital Improvements**  
at the  
**Jail (Public Safety Building)**

Whatcom County - Contract 201607005 – PHASE 1B

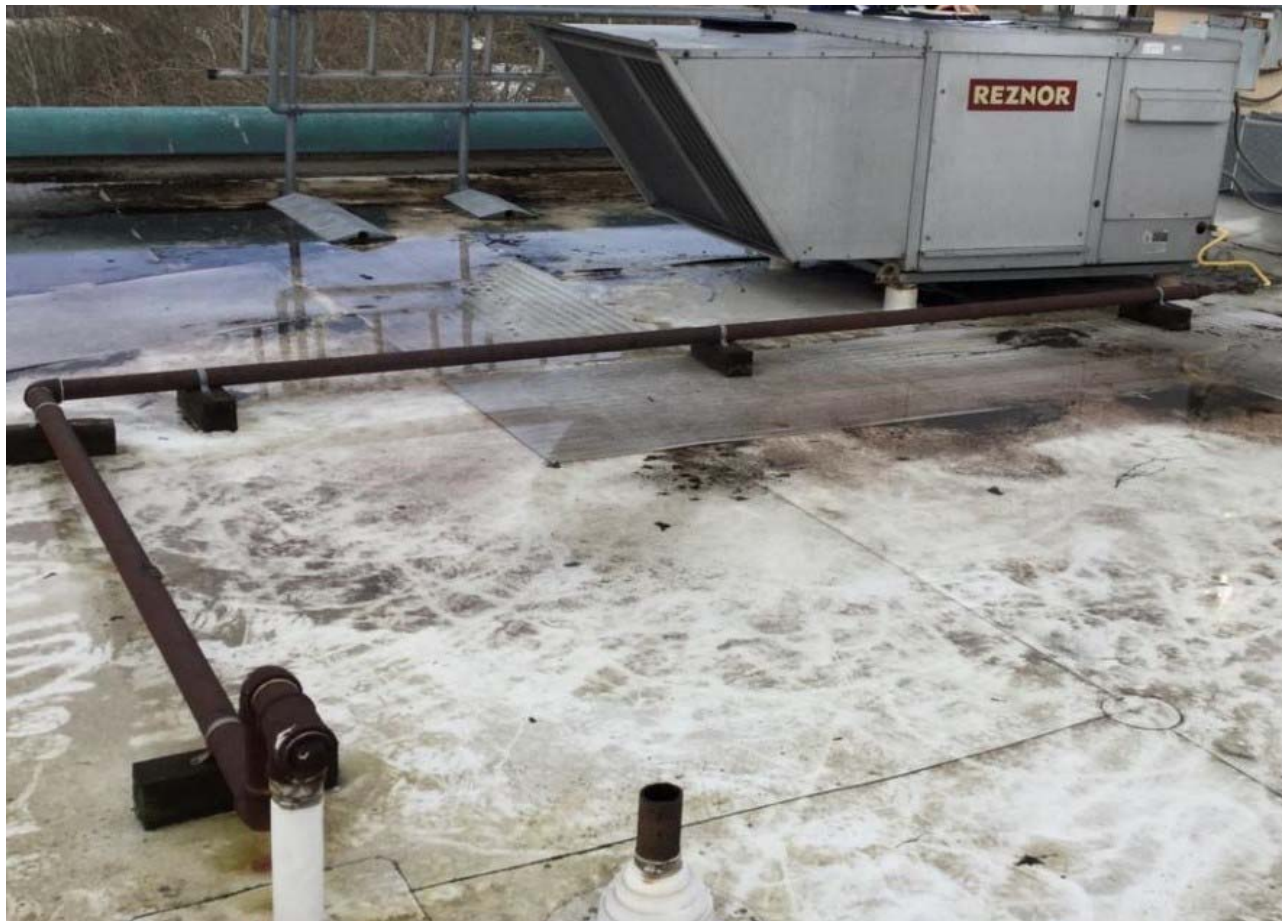
- b) The make-up unit is mounted on stanchions. The stanchions appear to be connected to the roof structure, however there is not a "positive" (bolt through or weld) attachment between the unit and the stanchions. In a seismic event the unit could simply slide off the stanchions disrupting the service to the building, damaging the roof and possibly causing a natural gas leak and fire.
- c) Exhaust fan #3 is supported by and welded to stanchions. The frame between the unit and stanchions is rusty. If the stanchions, frame and connections were engineered and the rust damage has not compromised the integrity of the restraint this unit should stay in place during a "maximum

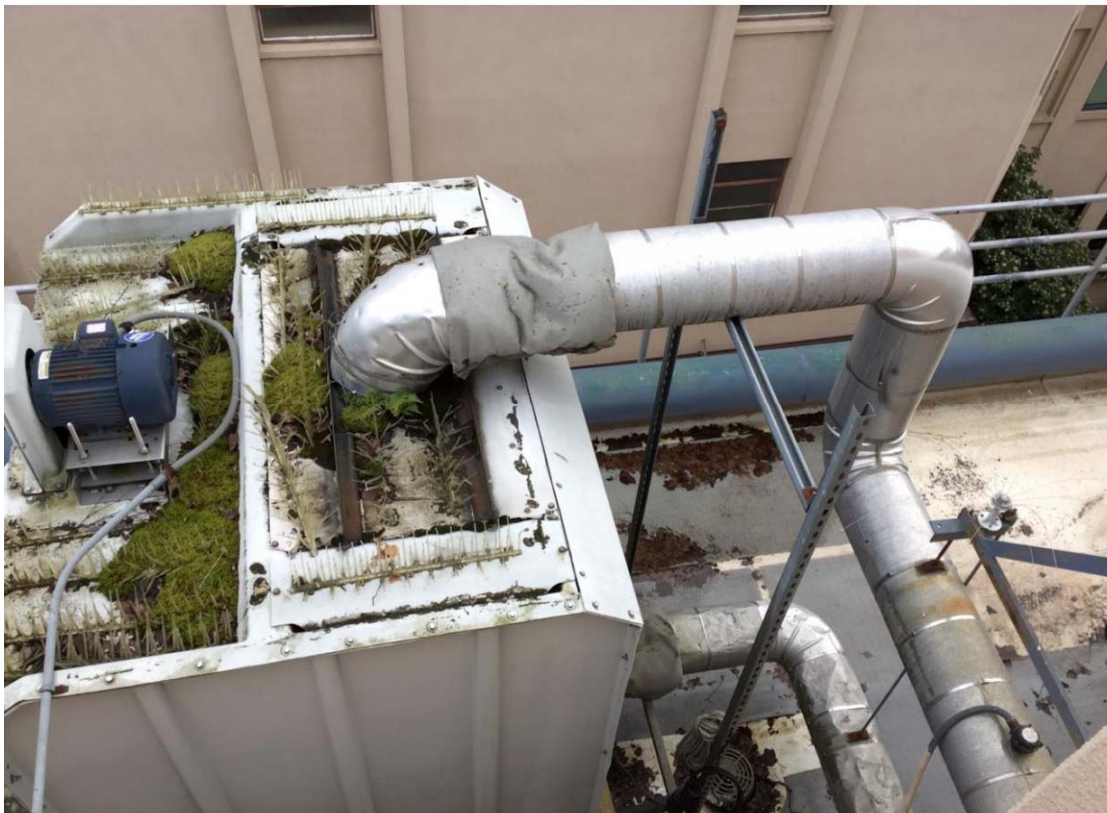
- 2) Mechanical Tray: The MPHEF systems and equipment in this area of the building are the most at risk due to the high concentration of unrestrained systems. During a seismic event, it is very likely that several systems and pieces of equipment will impact other equipment and systems causing a "domino effect" increasing the damage and system failures. There is limited access to the overhead concrete structure complicating the installation of new seismic restraints.
  - a) None of the suspended MPHEF utilities or mechanical units are seismically braced (refer to figure 3/6.03).

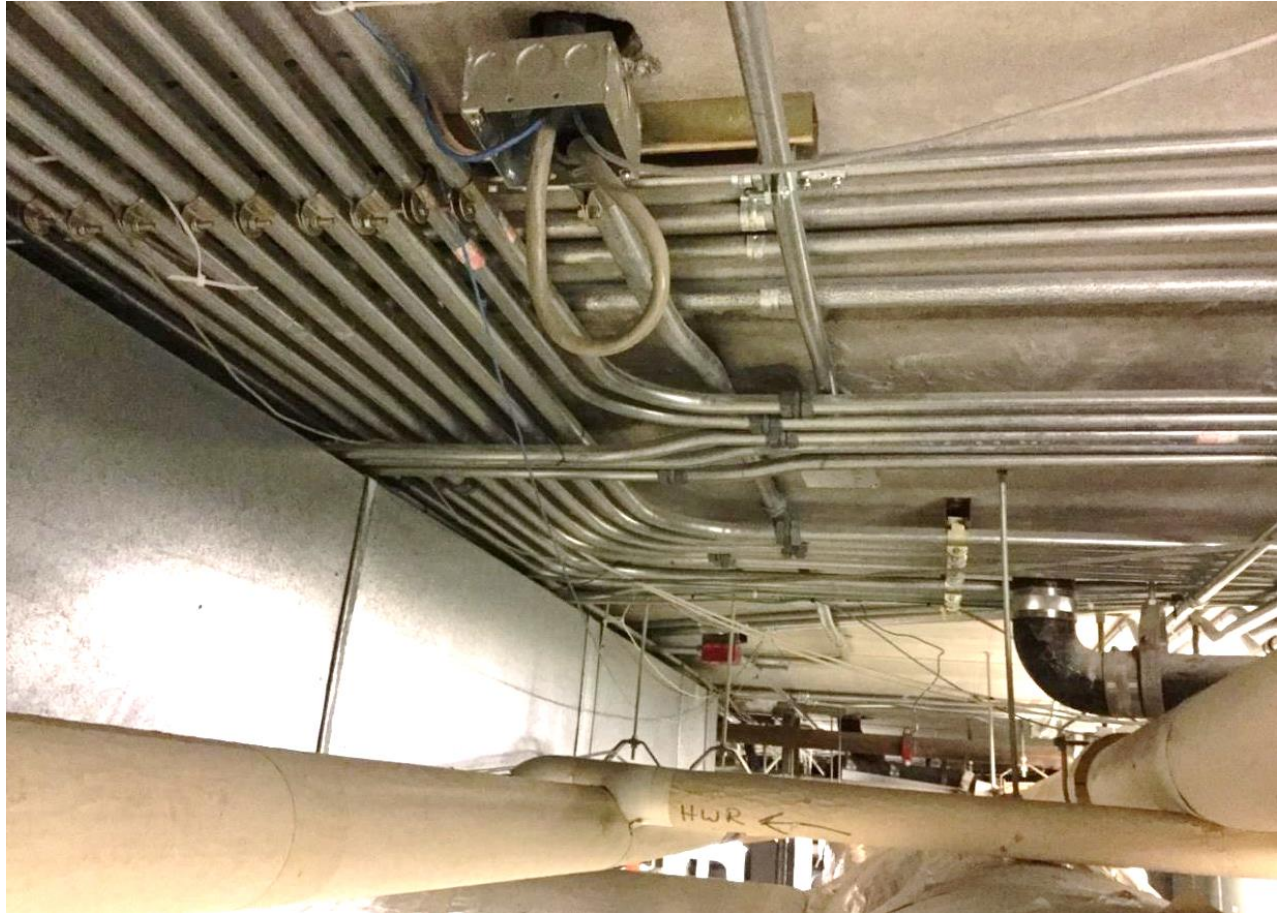
- b) The seven large base mounted mechanical units are all anchored with the same size anchors. It is unlikely the anchorages were engineered based on the size.
- c) Some base mounted duct supports and mechanical units are not anchored (refer to figure 3/6.04).

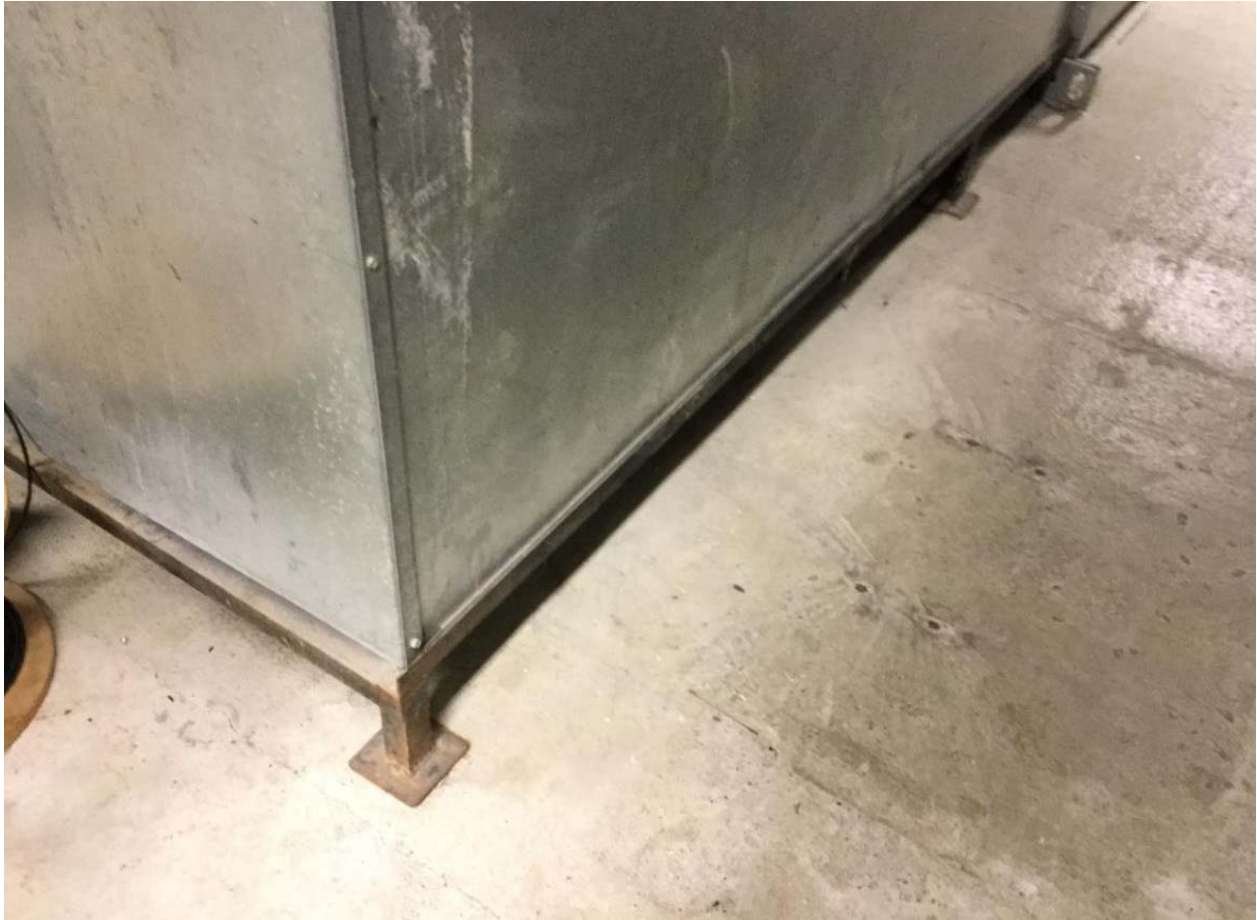
- d) The security pathway access control panels are mounted on a floor to ceiling strut stand. It is unclear if the stand has been engineered to accommodate seismic loading.
- e) Numerous electrical utilities are connected directly (not suspended) to the overhead concrete structure and the floor. The floor mounted systems could be disrupted or fail due to other utilities falling on them during a seismic event. The overhead electrical utilities will interfere with anchorage of bracing to the structure (refer to figure 3/6.03).
- f) There are several locations where a suspended utility is hanging from another suspended utility. These installations can amplify the seismic loading and reactions increasing the likelihood of failures (refer to figure 3/6.05).

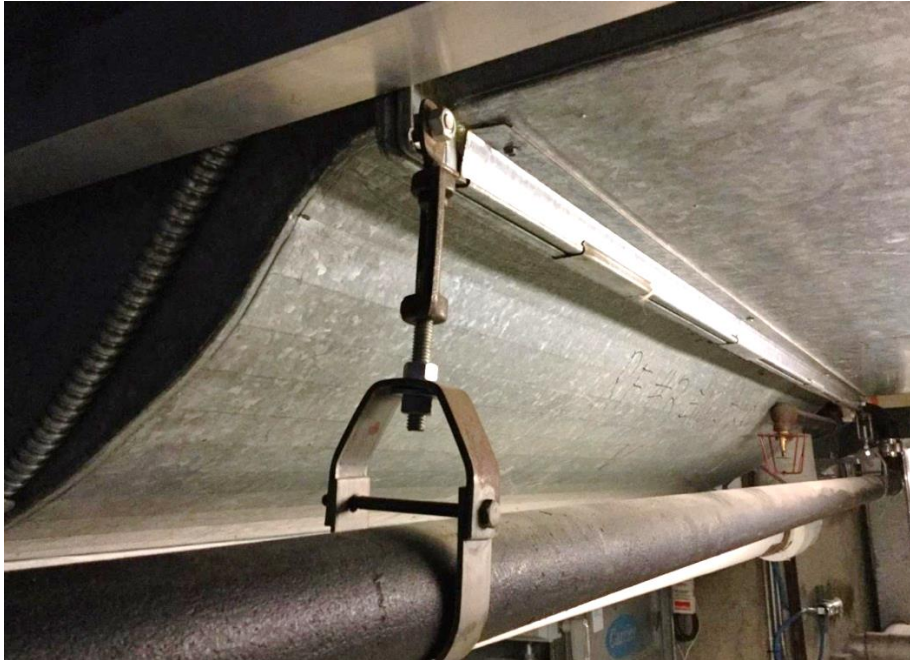
- g) Many of the supports have oversized holes through the bottom of the overhead hollow core planks. It is undetermined how they are anchored above or if the hangers can accommodate the additional loading that occurs during an earthquake. (refer to figure3/6.06).

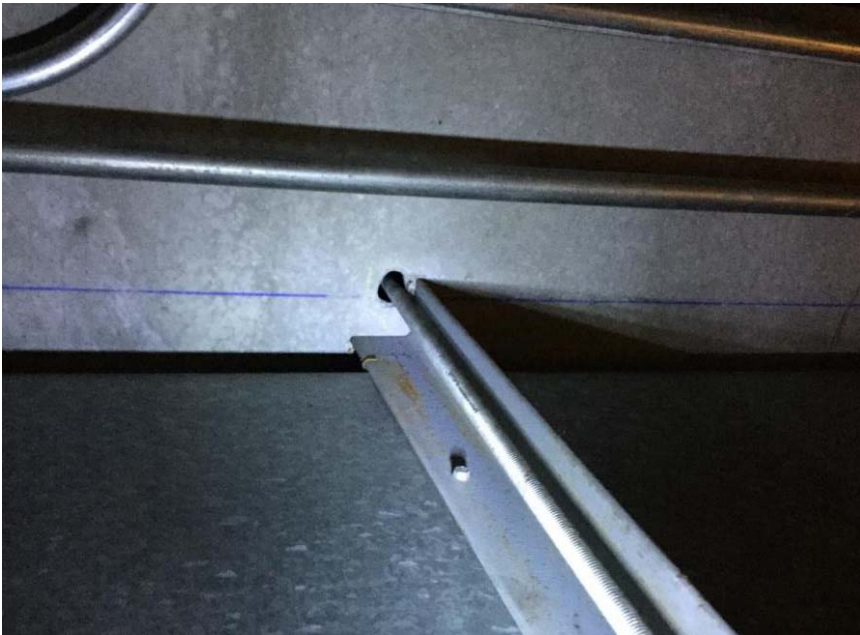
- 3) Basement Boiler/Mechanical and Electrical Rooms
  - a) Due to enclosures, unable to determine if the main electrical switch gear is adequately anchored.

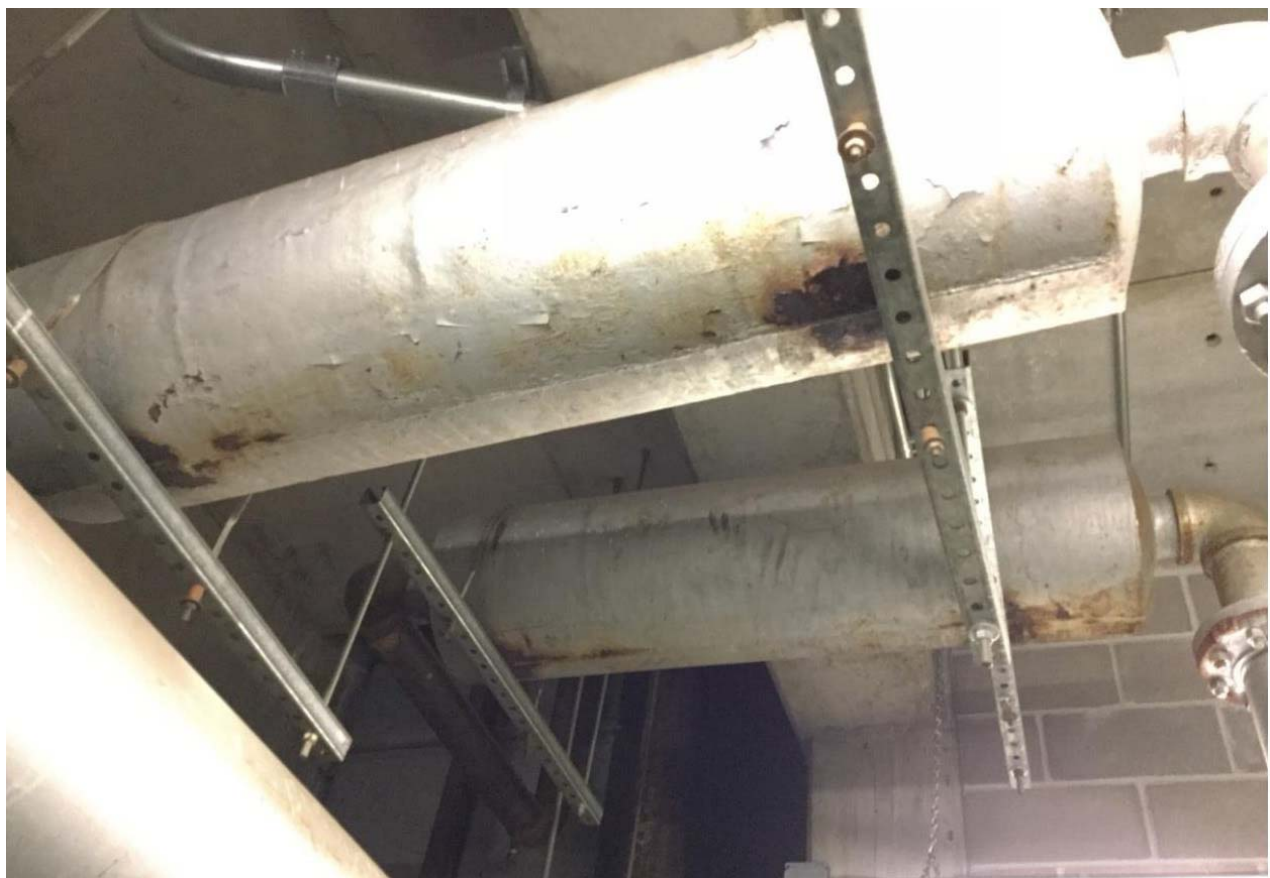
- f) Due to enclosures, unable to determine if the boilers are anchored properly.
- g) The chiller is likely to overturn during an earthquake because it is not anchored and has a high center of gravity (refer to figure 3/6.08).

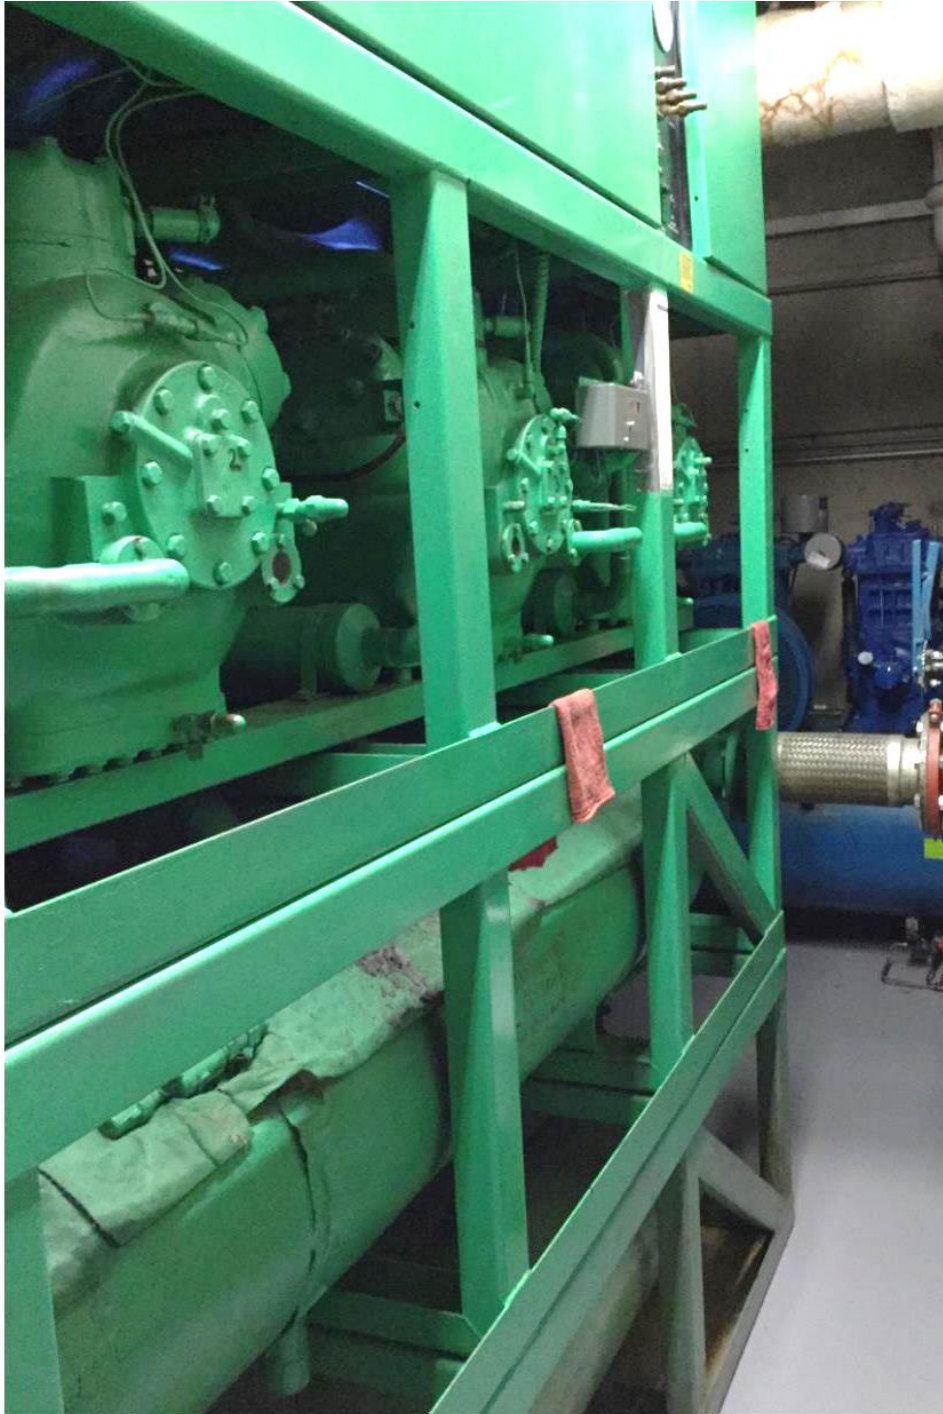
- h) None of the suspended piping or ducts are braced. Many hangers are loose and not supporting the utilities correctly (refer to figure 3/6.09).

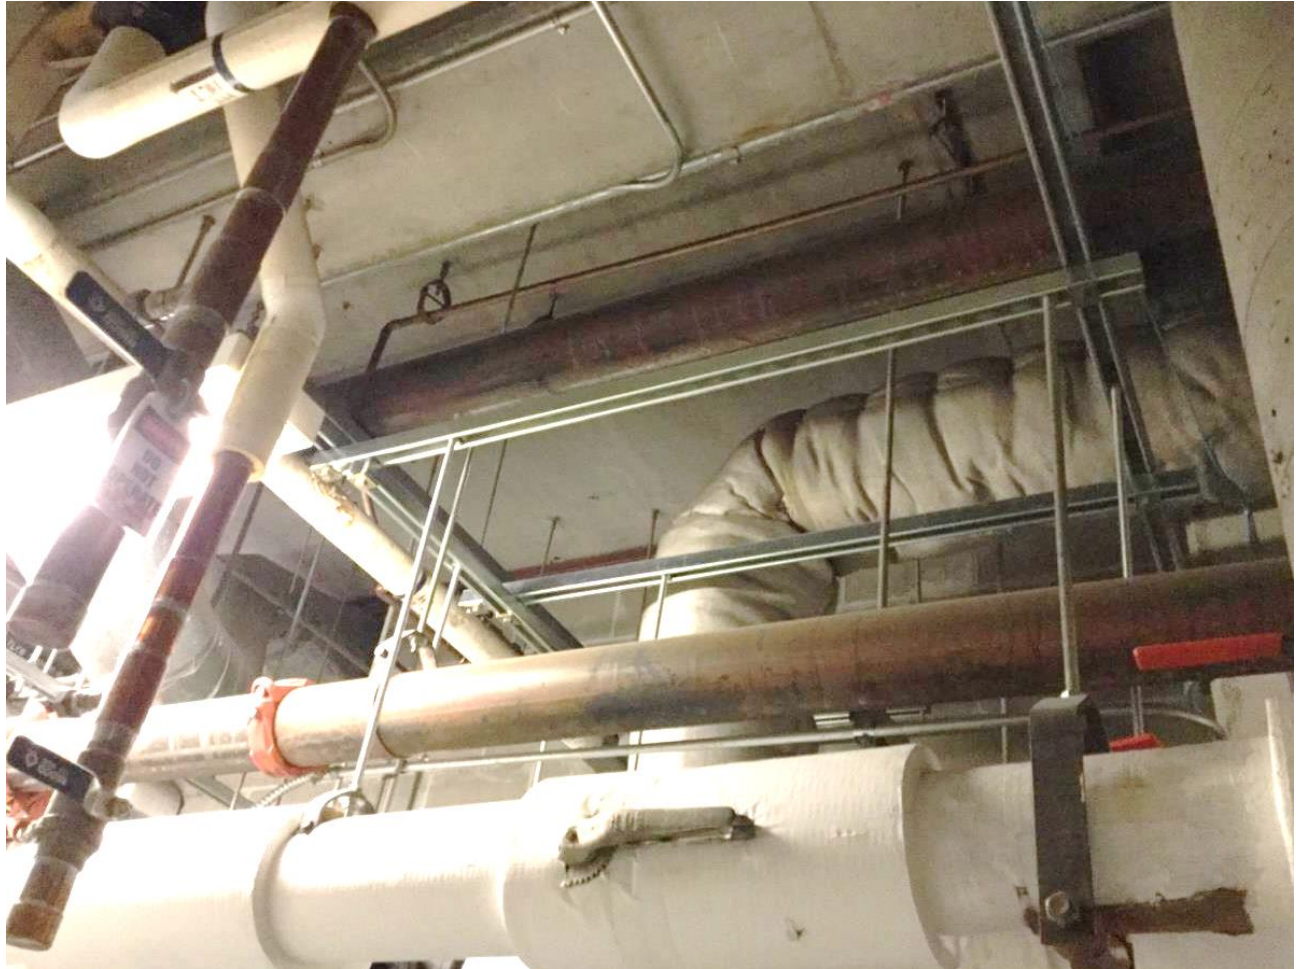
- i) Floor mounted water heaters, storage tank and abandoned air compressor are anchored. These anchors should be checked to ensure they are sized properly.

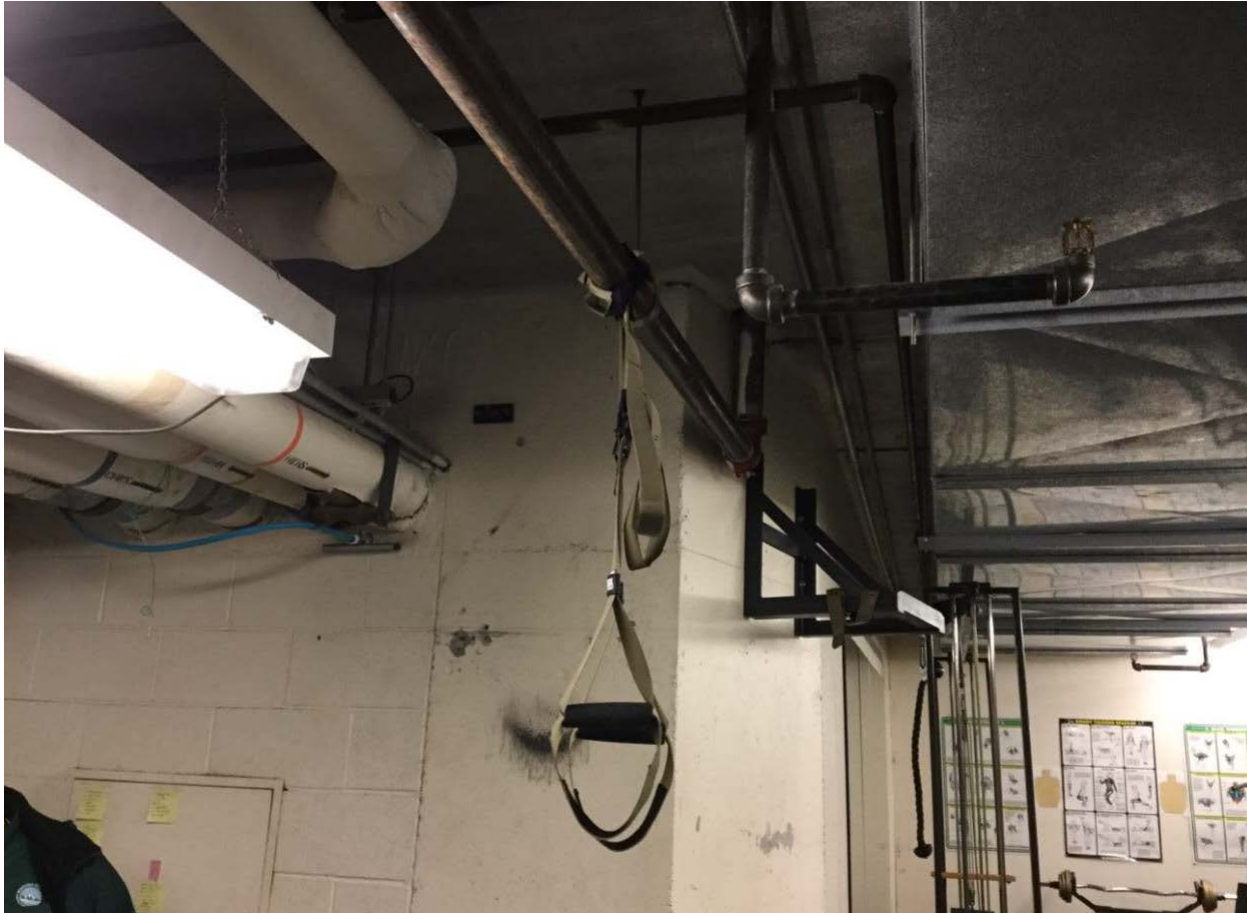
- g) There are several locations where a suspended utility is hanging from another suspended utility, including a suspended mechanical unit hanger screwed to the bottom of a large duct in the kitchen area. These installations can amplify the seismic loading and reactions increasing the likelihood of failures.
  - h) Some HVAC units are suspended on straps while other units are suspended with all-thread rod. Units that are suspended via straps need to have new hangers that utilize all thread rods and code complaint anchors.
- 5) First, second and third floor Electrical rooms
- a) Some wall mounted equipment and conduits anchored to walls with non-code compliant anchors (refer to figure 3/6.11).

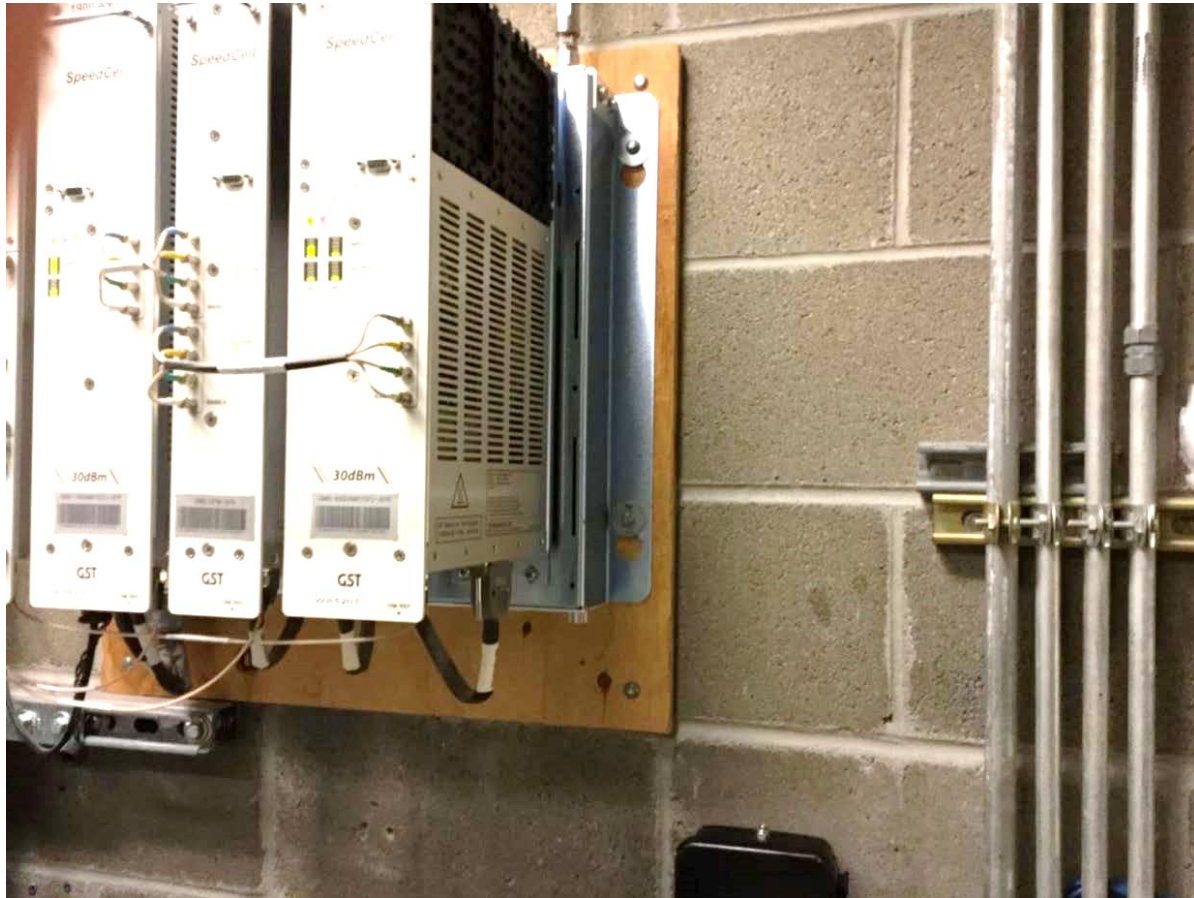
- b) Suspended electrical raceways are not braced.
- 6) Fire protection system
- a) Some bracing is installed on the vertical risers in the stairwells (refer to figure 3/6.12).

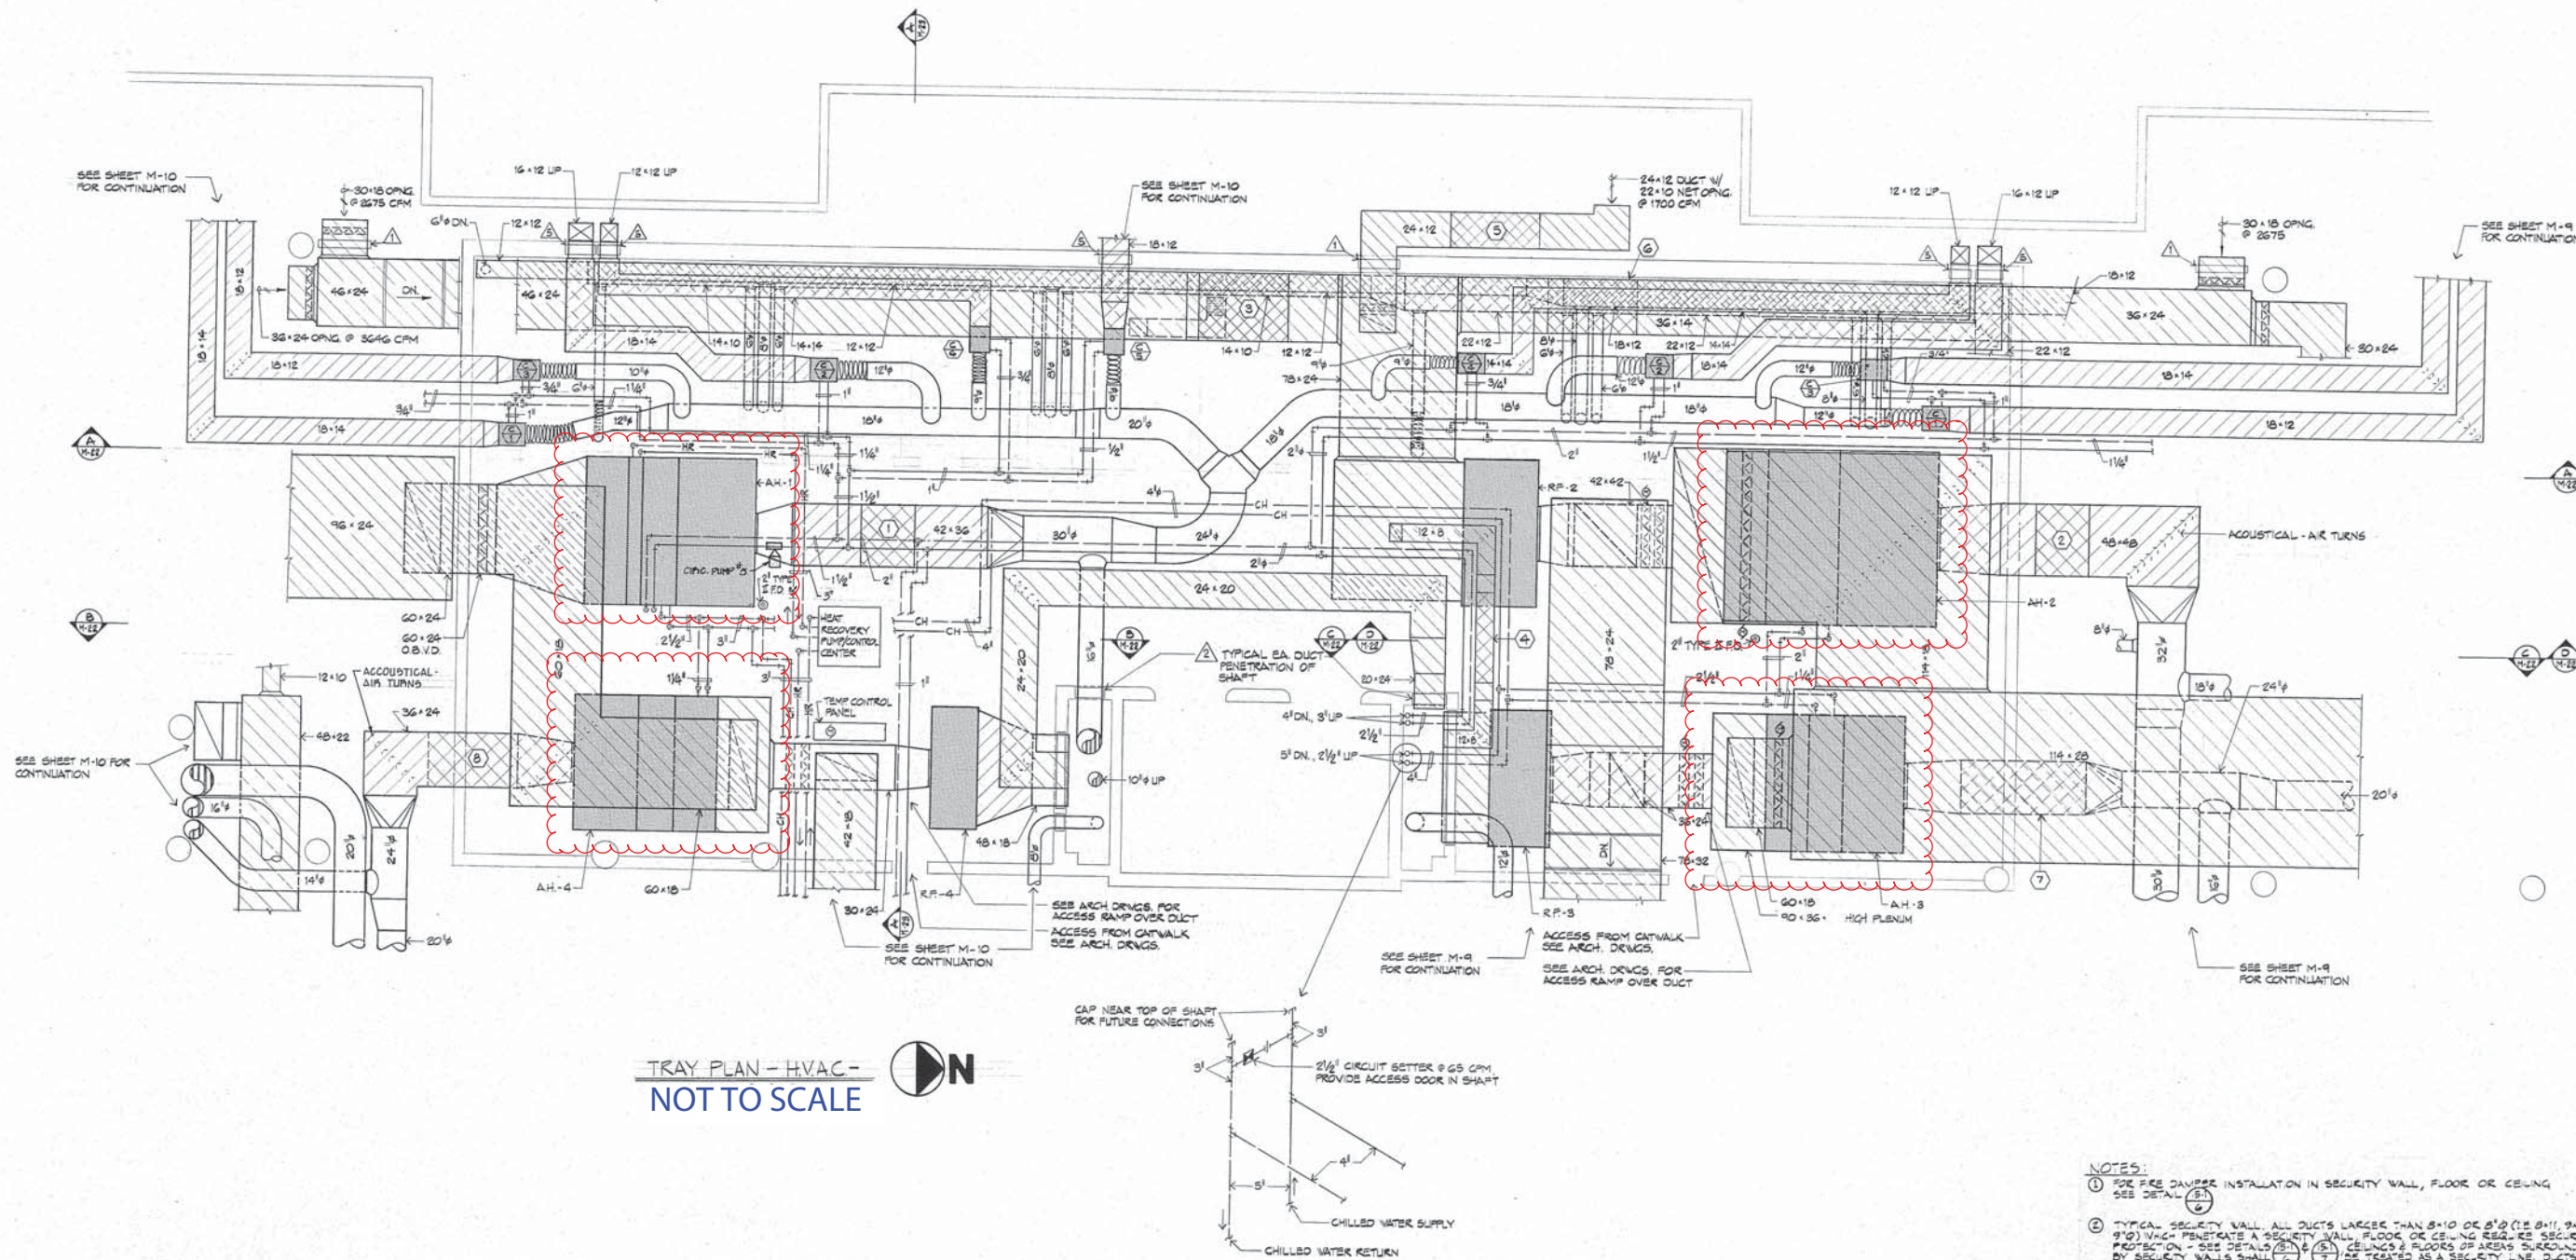
TRAY PLAN - HVAC -  
NOT TO SCALE

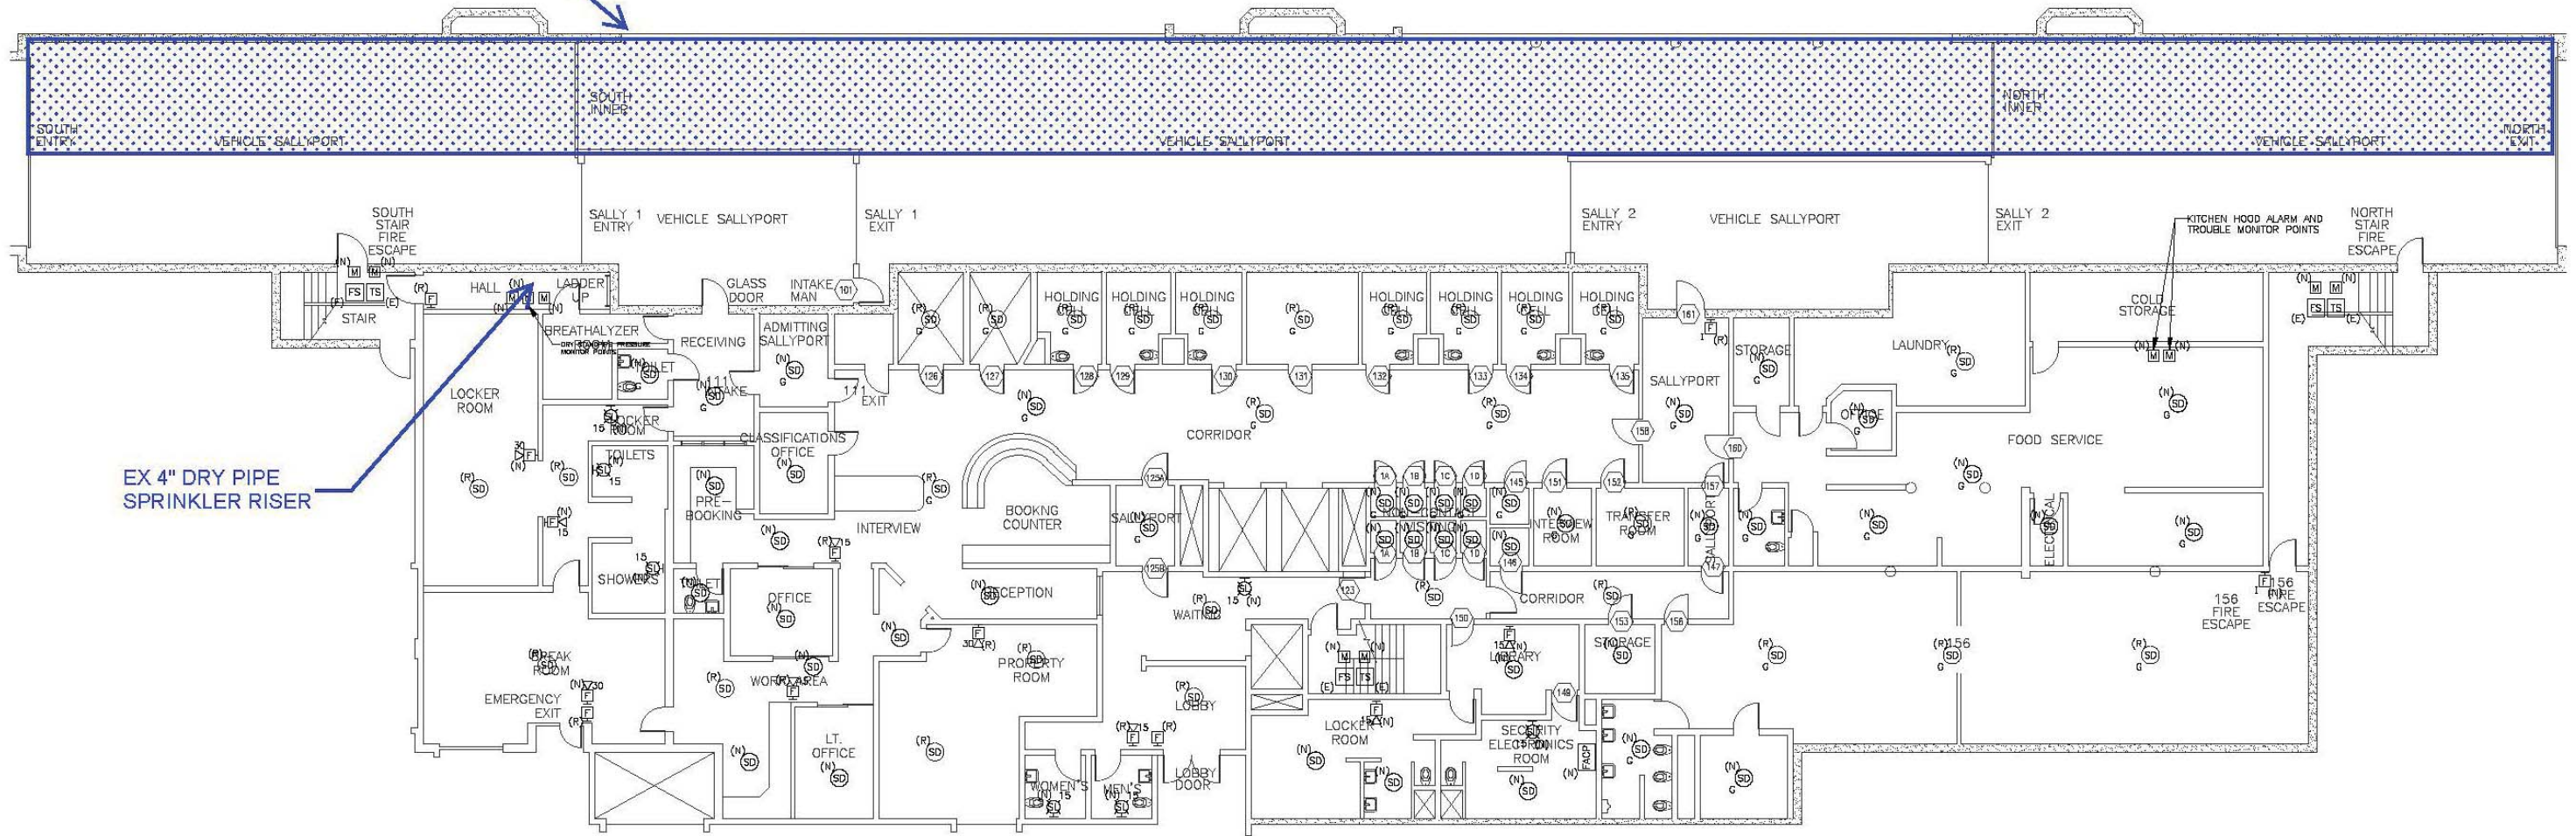
**SCOPE OPTION 5-2 - EXTEND WET PIPE AND DRY PIE SPRINKLER PROTECTION TO UNSPRINKLERED AREAS IN THE BASEMENT, FIRST, MEZZANINE, AND SECOND FLOORS**

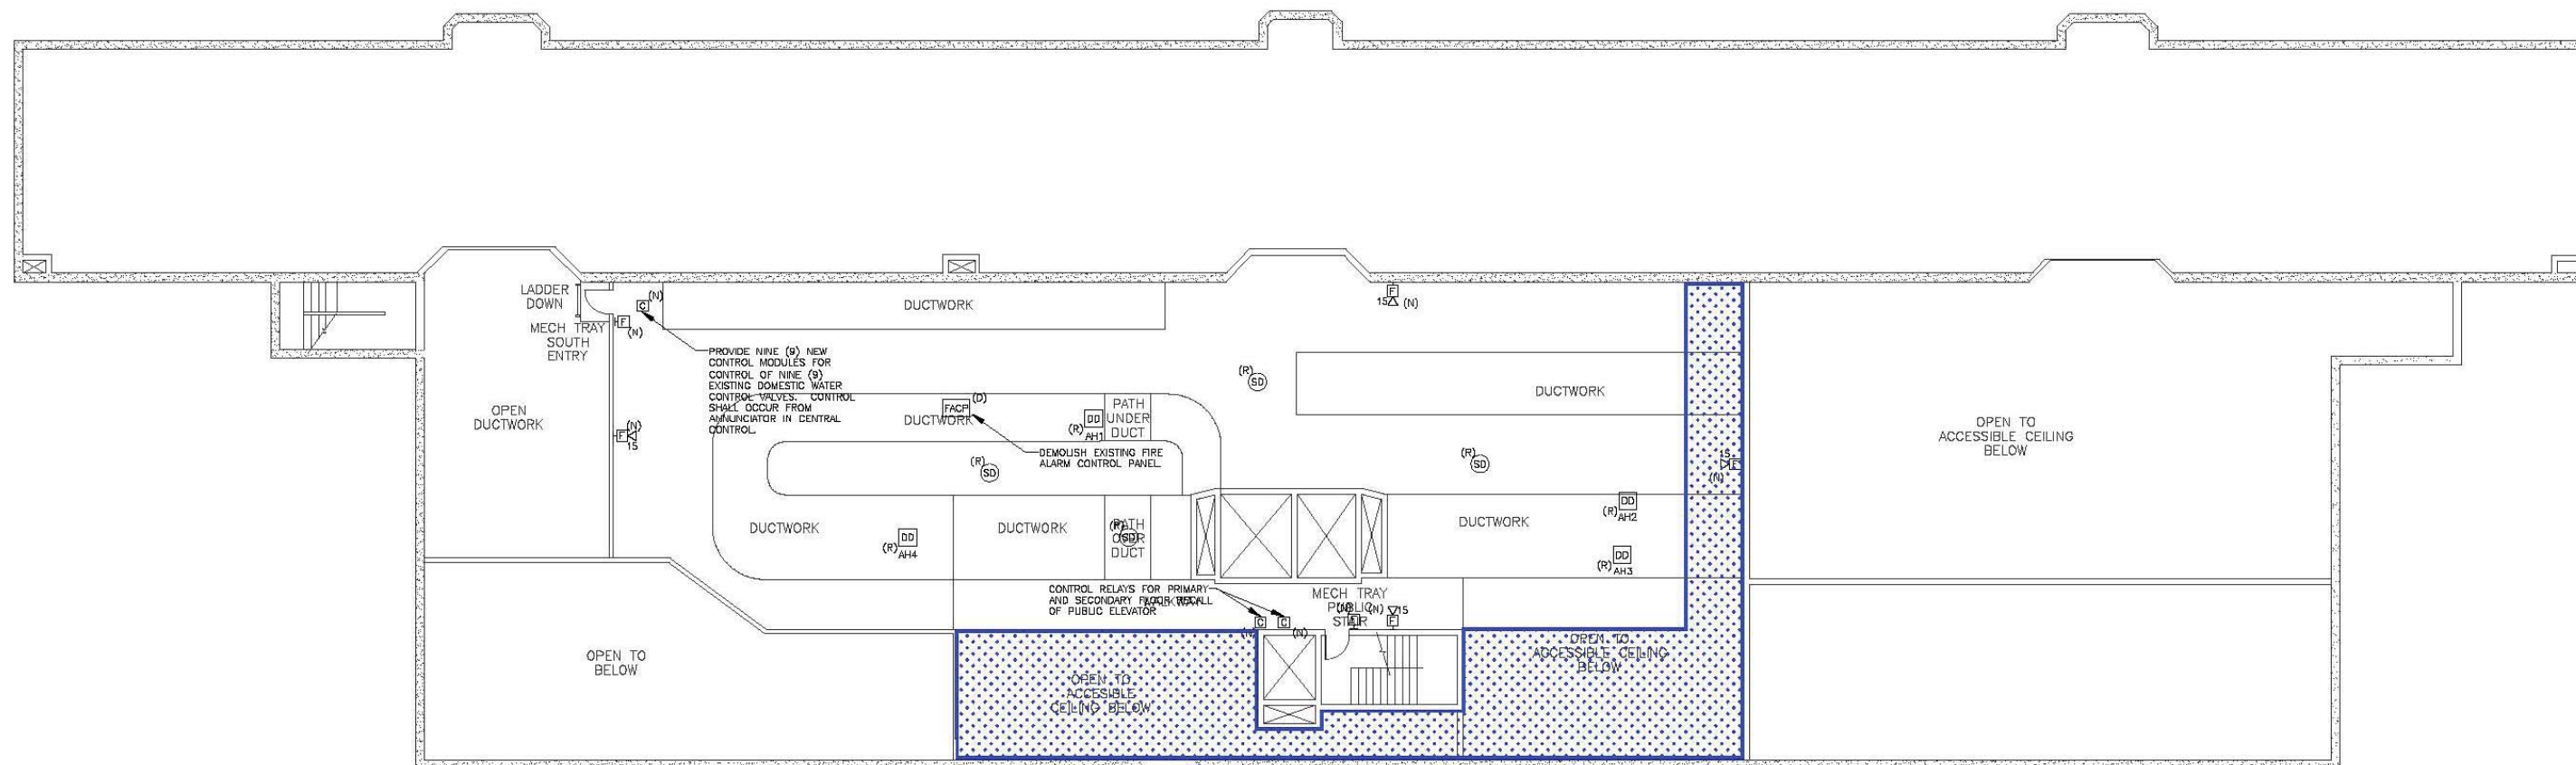
SCOPE OPTION 5-2 - EXTEND WET PIPE AND DRY PIE SPRINKLER PROTECTION TO UNSPRINKLERED AREAS IN THE BASEMENT, FIRST, MEZZANINE, AND SECOND FLOORS  
**INCOMPLETE SPRINKLER COVERAGE PER NFPA 13 - 4.1 (INADEQUATE COVERAGE AND OVERSPACED SPRINKLERS)**

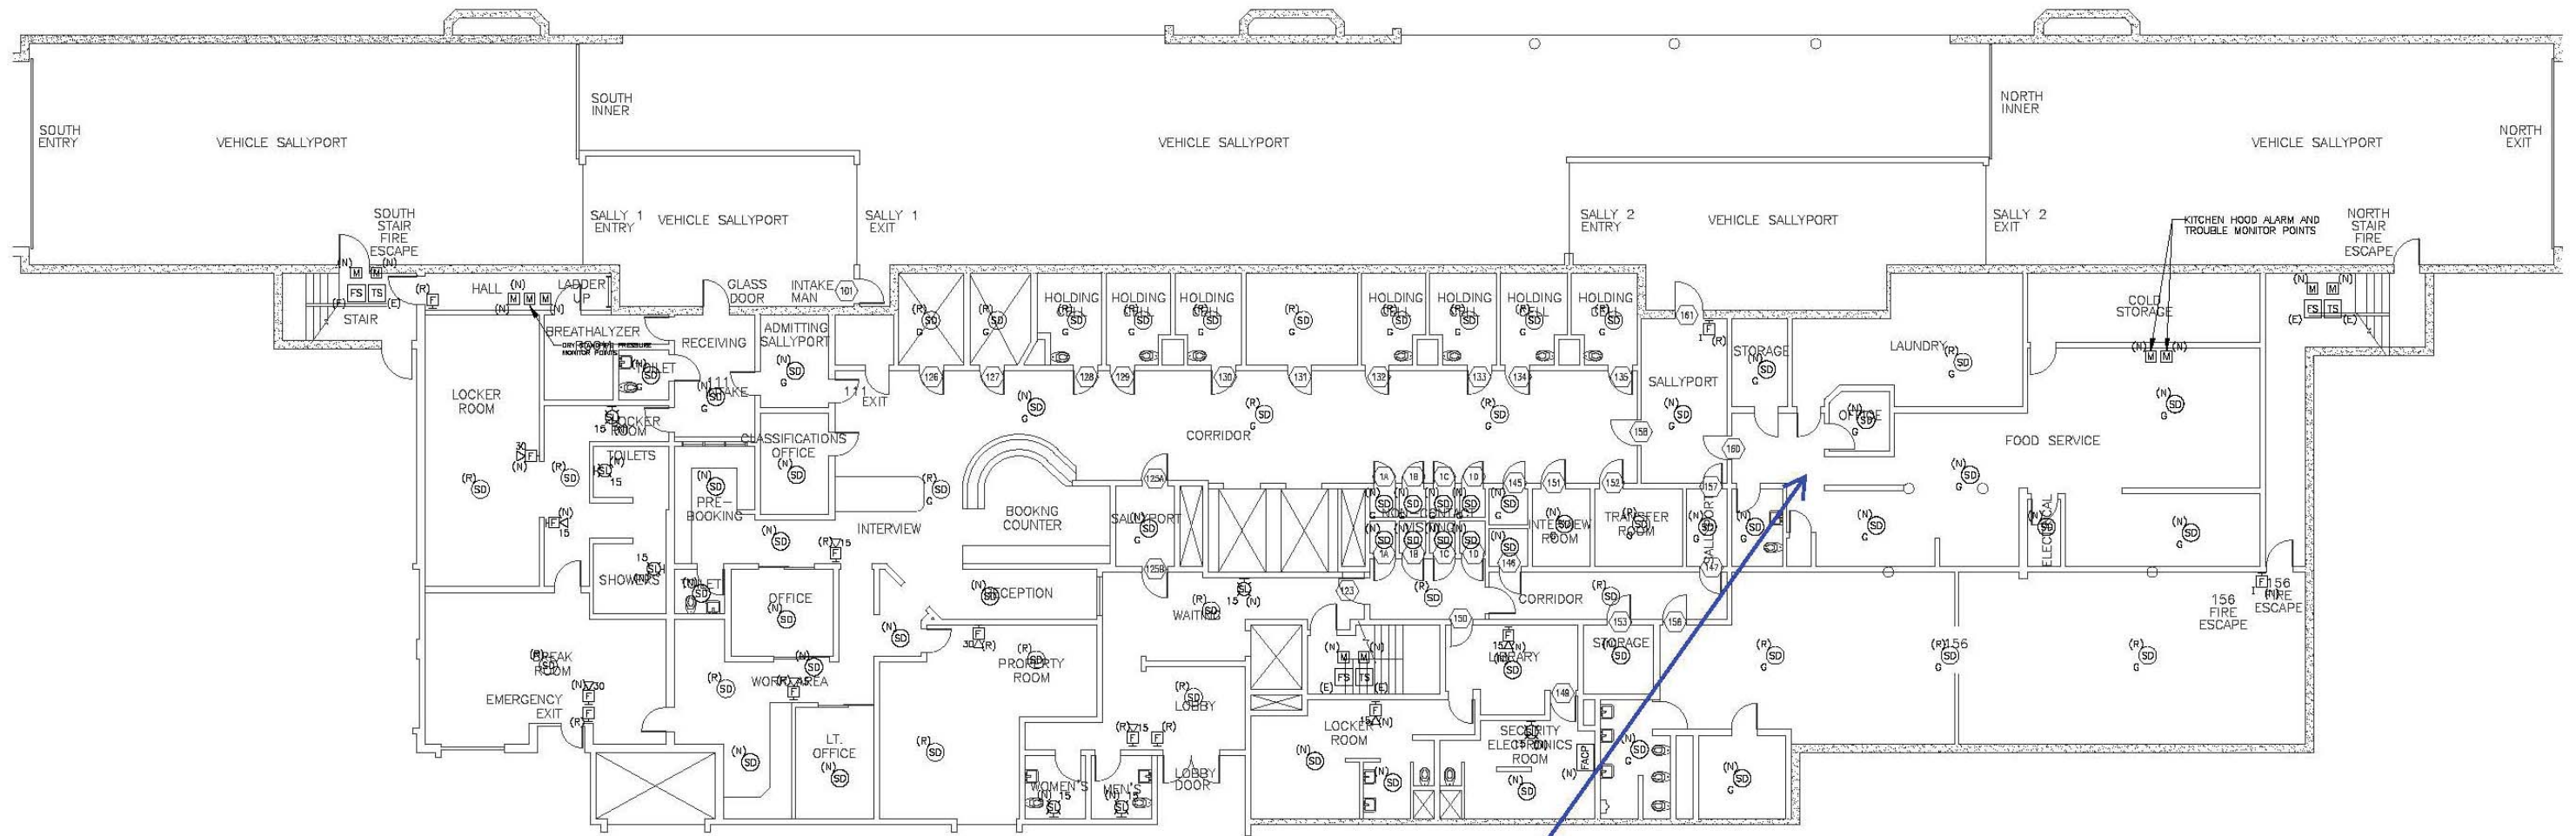
SCOPE OPTION 5-3 - MAINTENANCE AND REPAIR OF MINOR DEFICIENCIES.

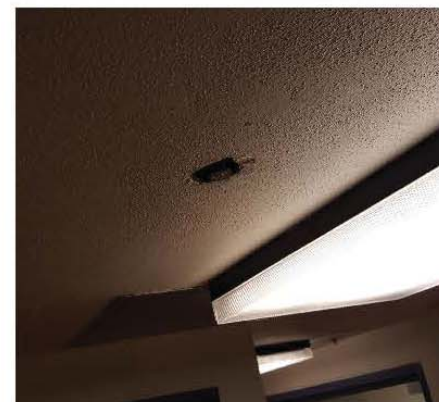
INSUFFICIENT DEFLECTOR-TO-CEILING CLEARANCE (1/2" MIN) CREATES SPRAY PATTERN DEFICIENCY. MISSING ESCUTCHEON.

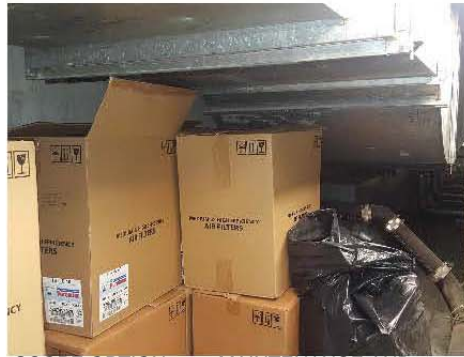
SCOPE OPTION 5-3 - MAINTENANCE AND REPAIR OF MINOR DEFICIENCIES.  
**NO SPRINKLER COVERAGE BELOW DUCTWORK >4 FT WIDE PER NFPA 13 - 8.5.5.3.1**
