**Building Assessment Studies and Cost Estimates**  
for  
**Capital Improvements**  
at the  
**Jail (Public Safety Building)**

Whatcom County - Contract 201607005 – PHASE 1B

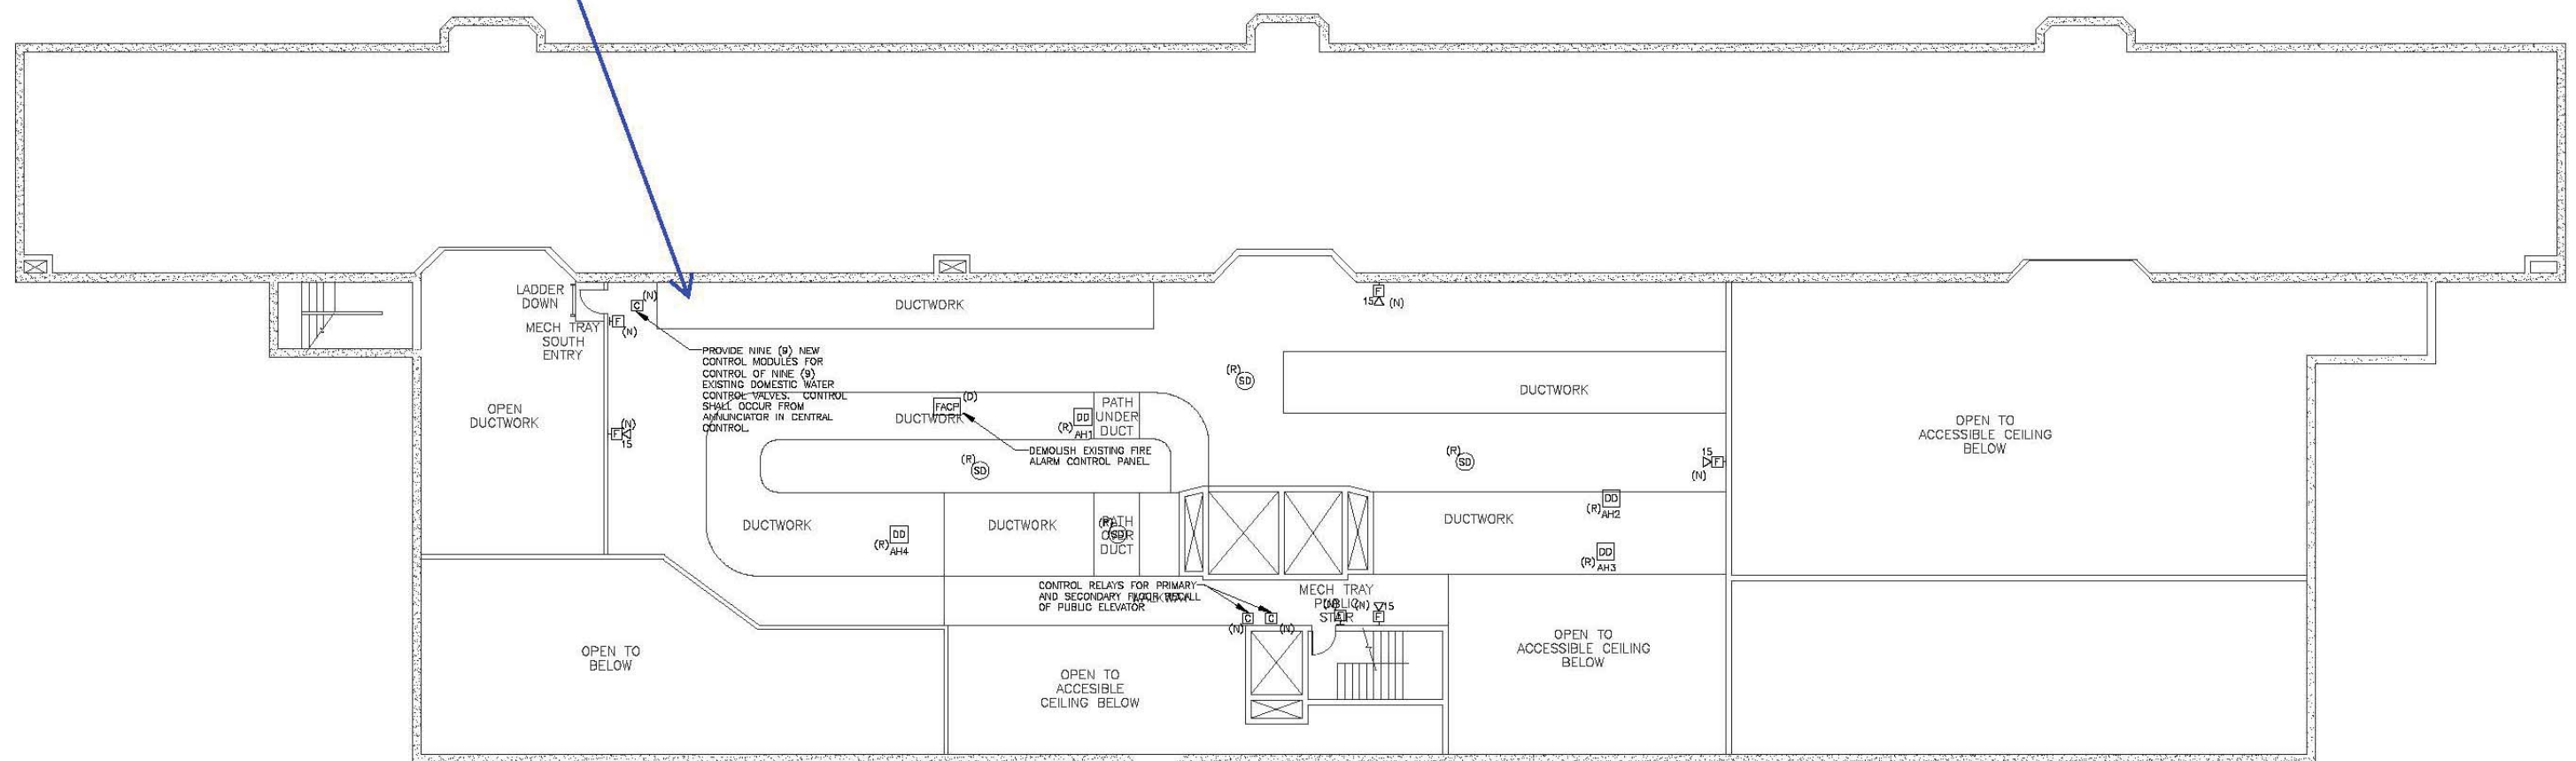
## TASK 7 - SMOKECONTROL SYSTEM ...TAB E

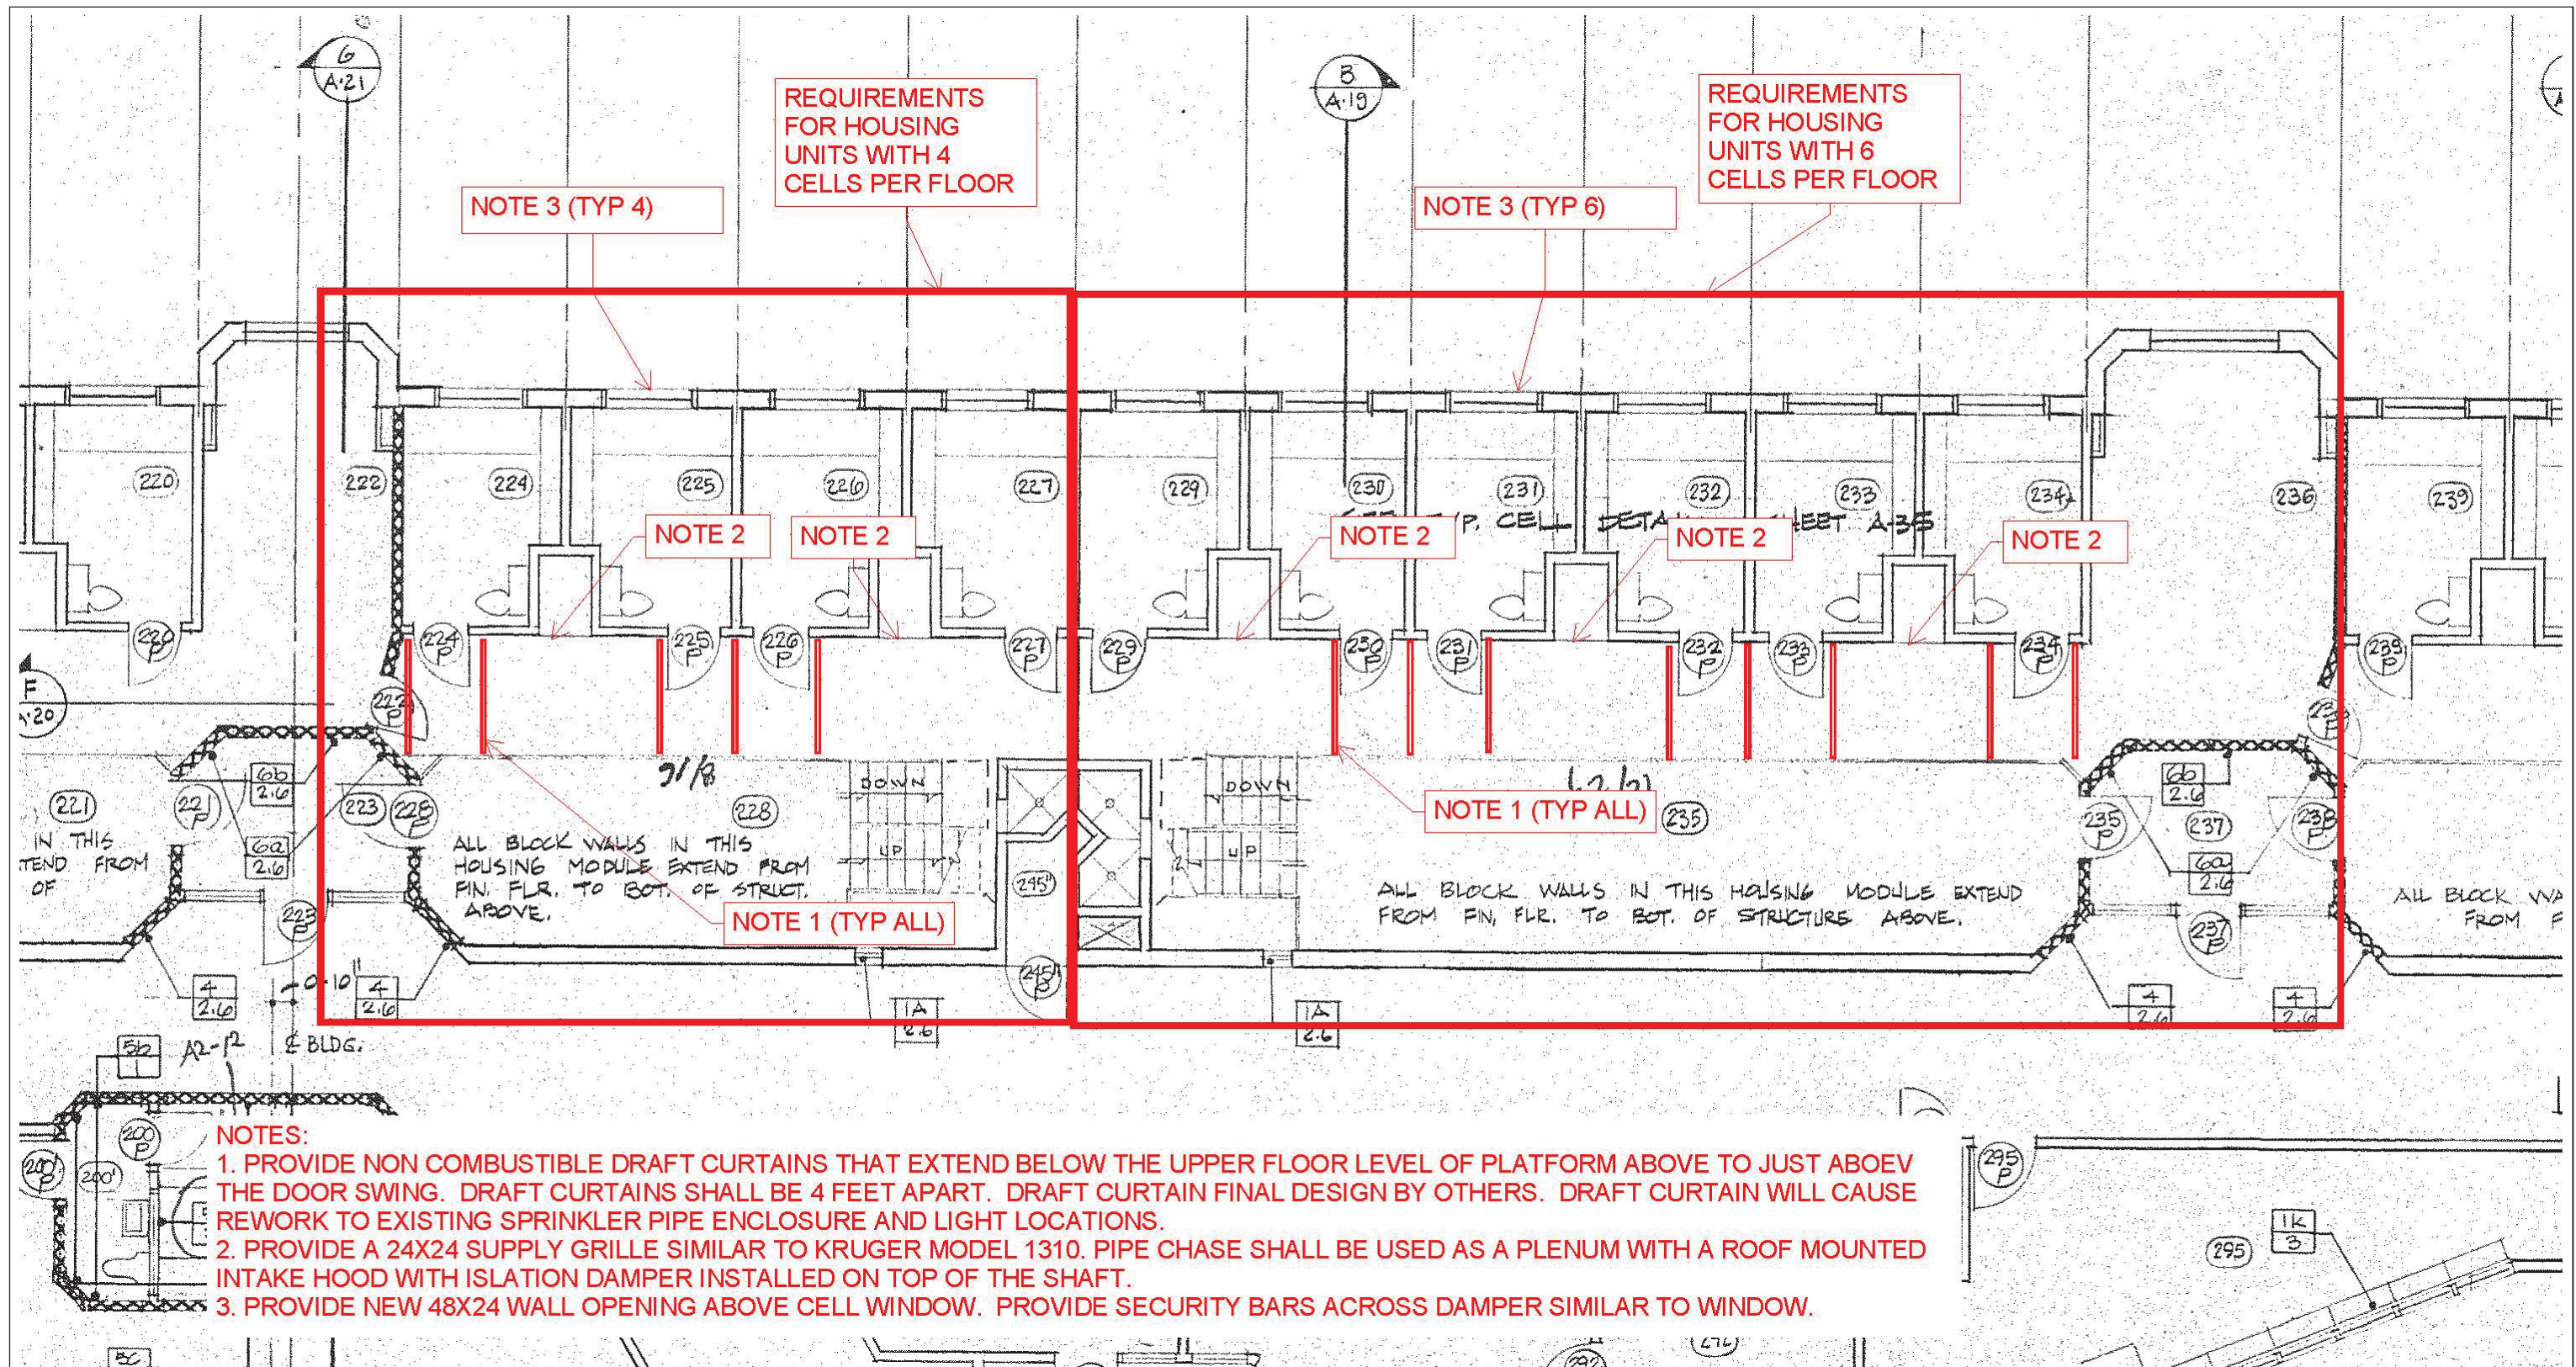
PHASE 1B - JAIL ASSESSMENT  
WHATCOM COUNTY  
BELLINGHAM, WA

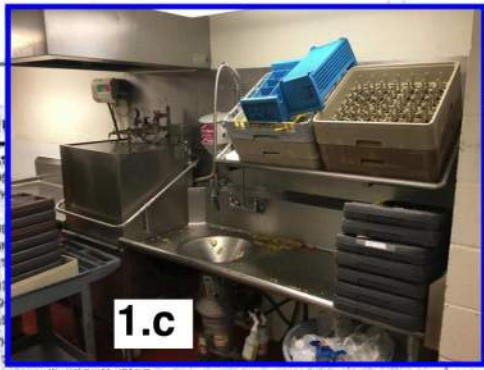
8. PROVIDE ADEQUATE VENTILATION FOR SELF-CONTAINED REFRIGERATION UNITS BY ENCLOSED REFRIGERATION UNITS TO PREVENT OVER-HEATING AND SURVIVAL OF UNITS.

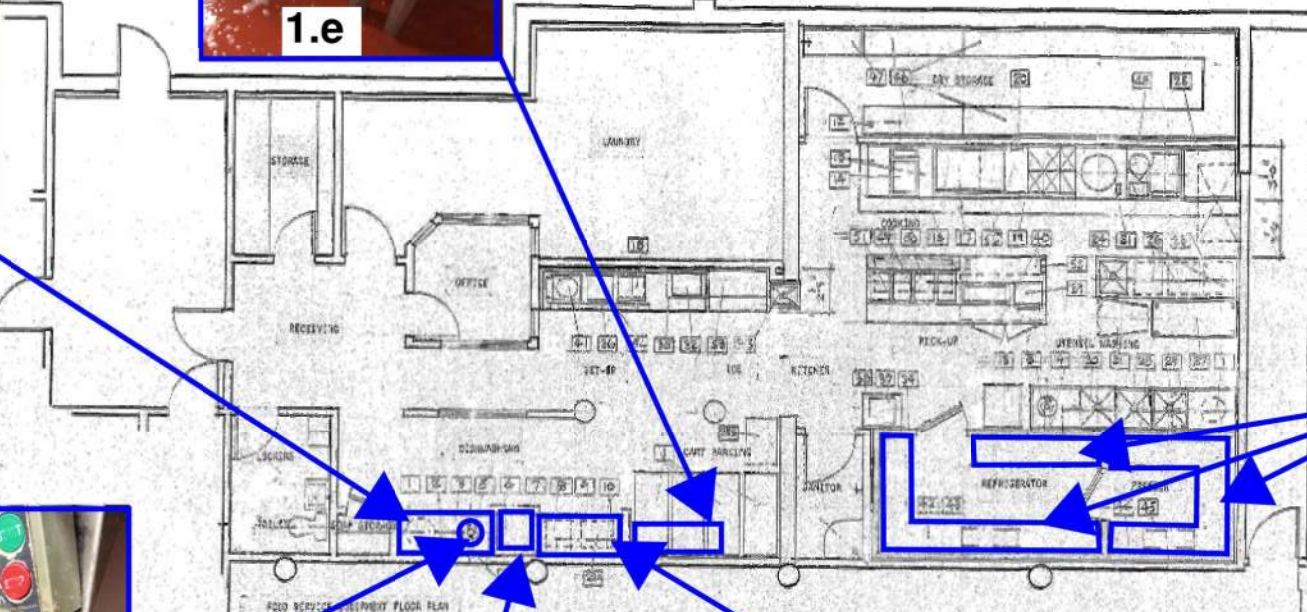
FOOD SERVICE EQUIPMENT SCHEDULE

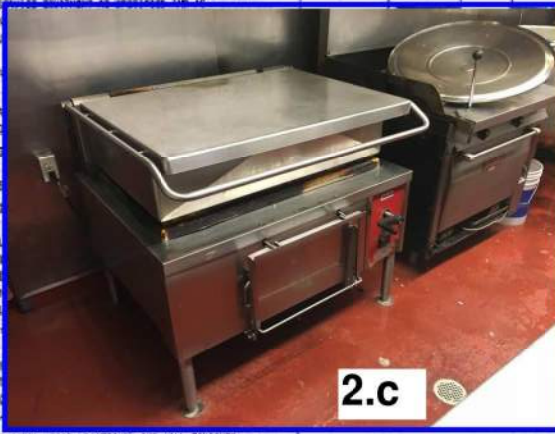
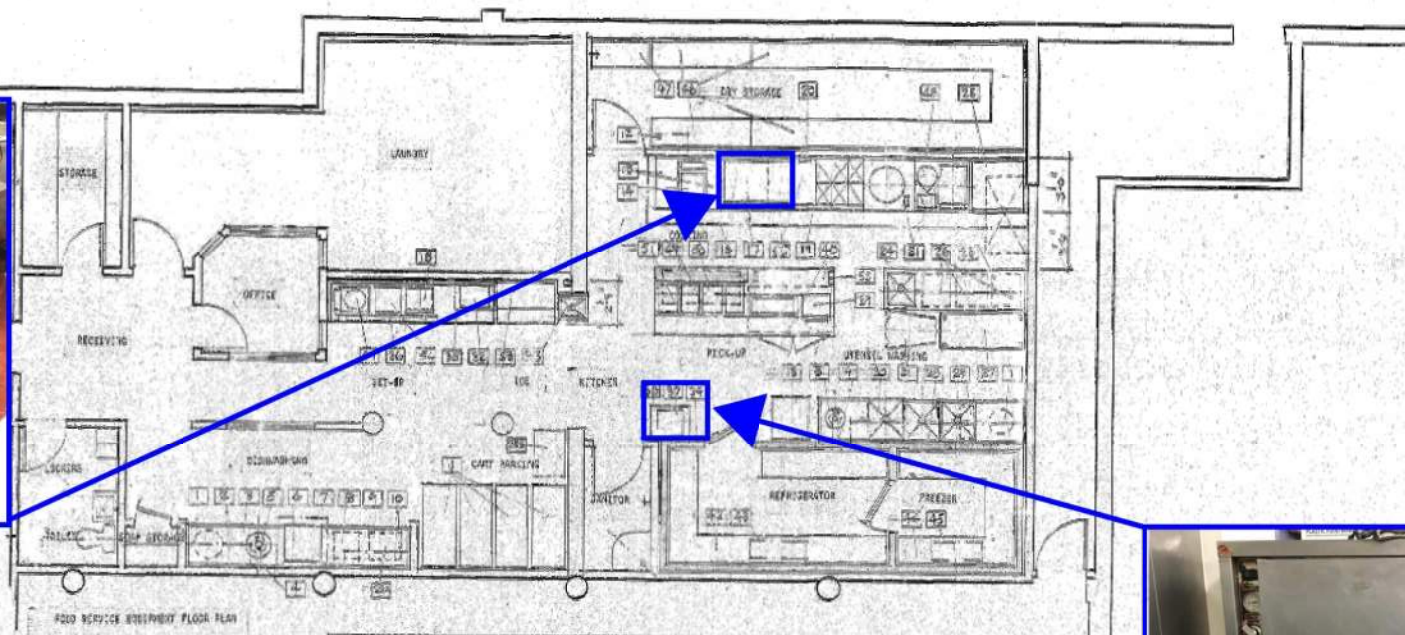
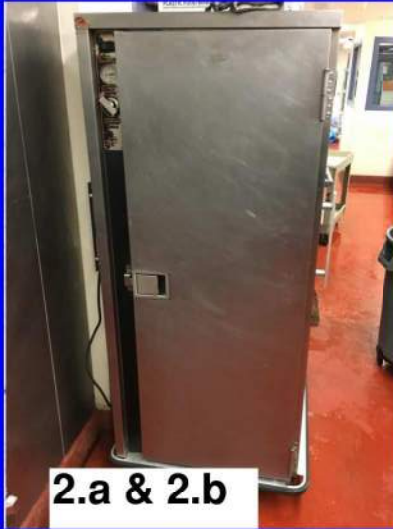
**FOOD SERVICE EQUIPMENT SCHEDULE**

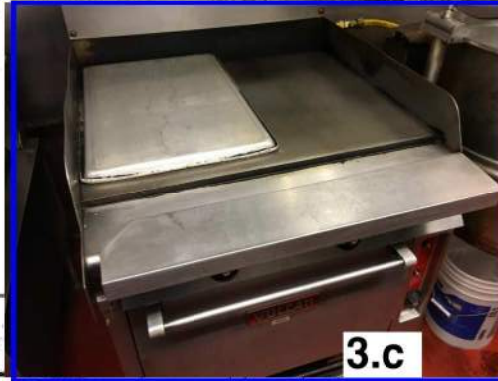
- PROVIDE ADEQUATE VENTILATION FOR SELF-CONTAINED REFRIGERATION UNITS IN ENCLOSED SPACES TO PREVENT OVER-HEATING AND SURVIVAL OF UNITS.

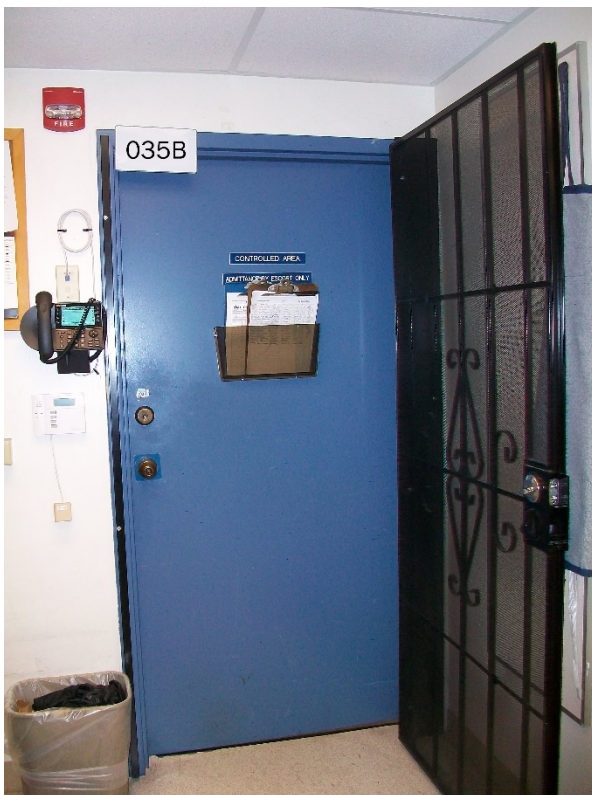
Figure 9.01: Door 035B-to Evidence Storage

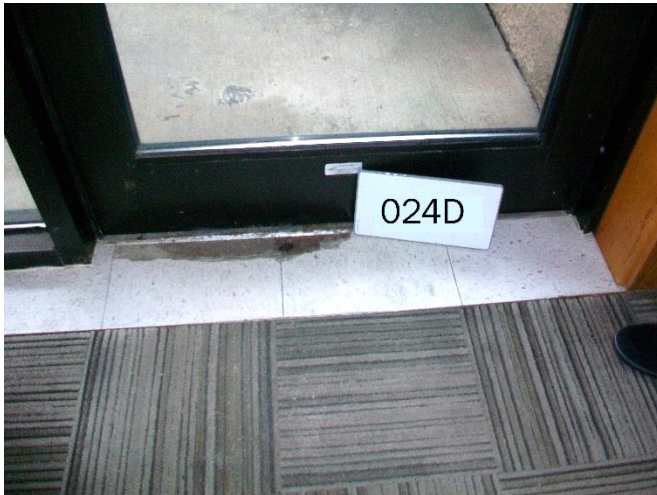
Figure 9.02: Door 024D showing damaged floor tiles.

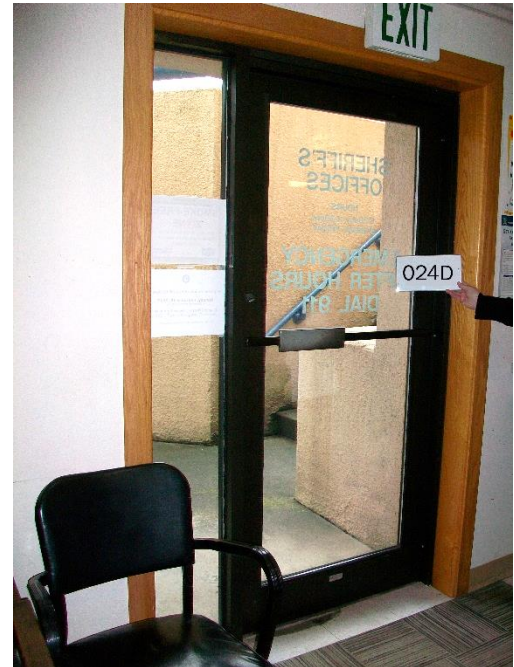
Figure 9.03: Door 024D

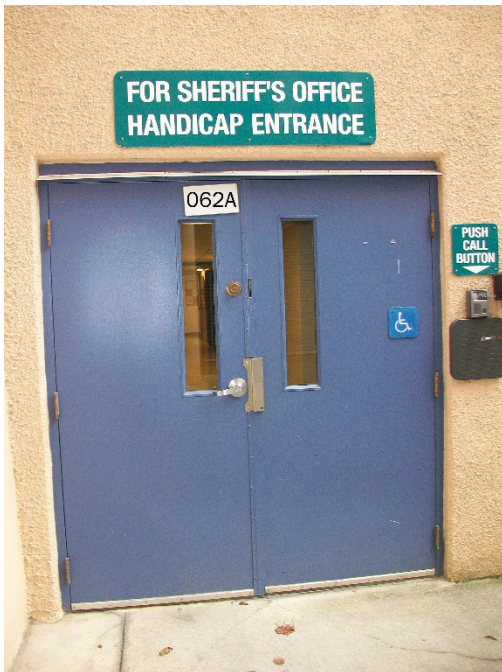
Figure 9.04: Door 062A showing exterior

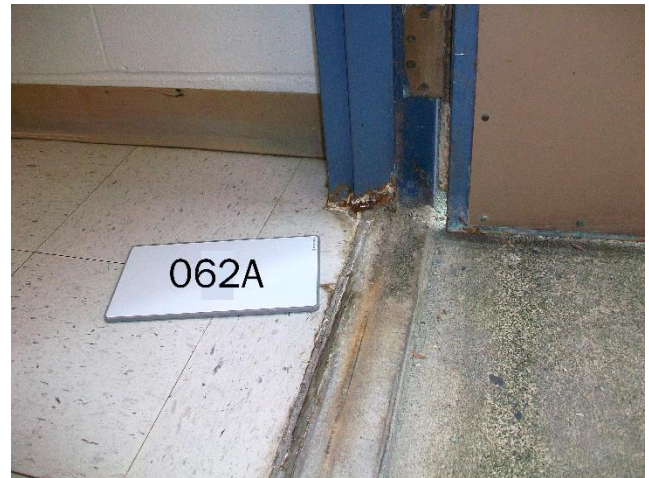
Figure 9.05: Door 062A showing condition of threshold and frame

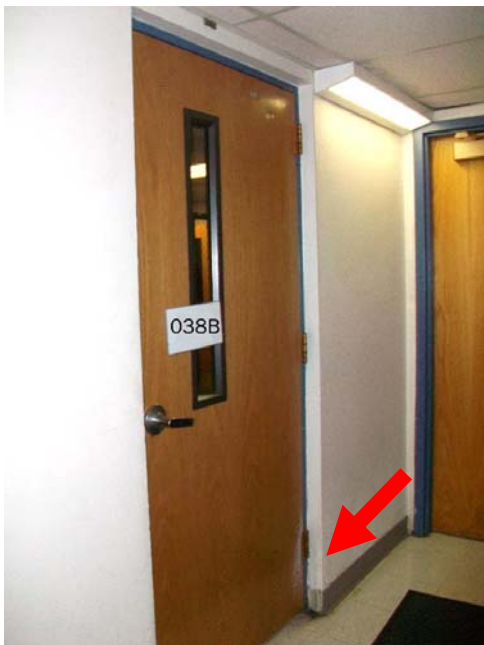
Figure 9.06: Door 038B shows signs of damage at wall and loose base.

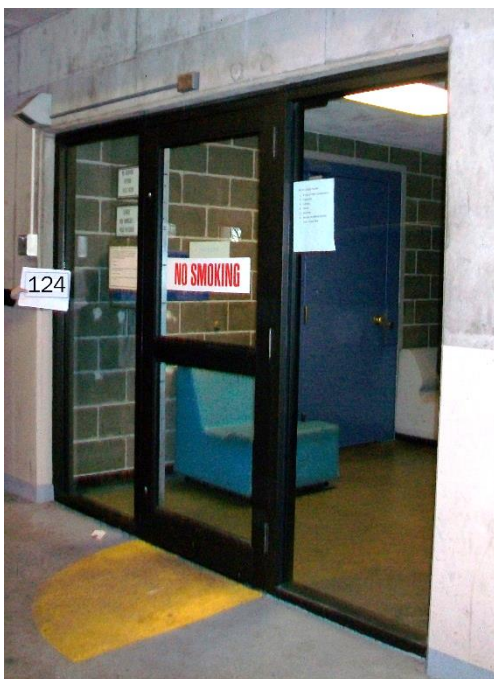
Figure 9.07: Door 124 -Sally port side

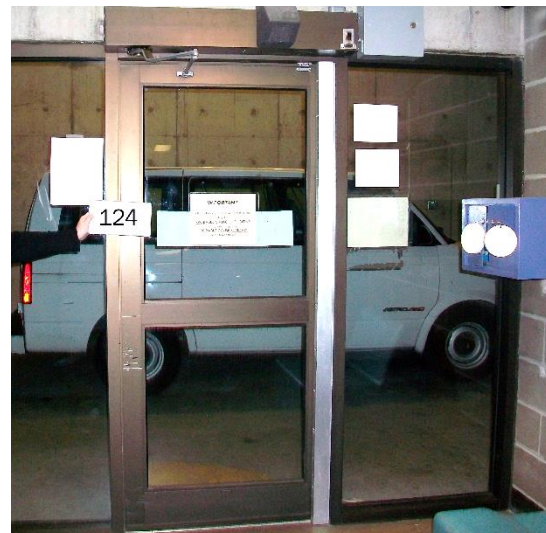
Figure 9.08: Door 124-Reception Side

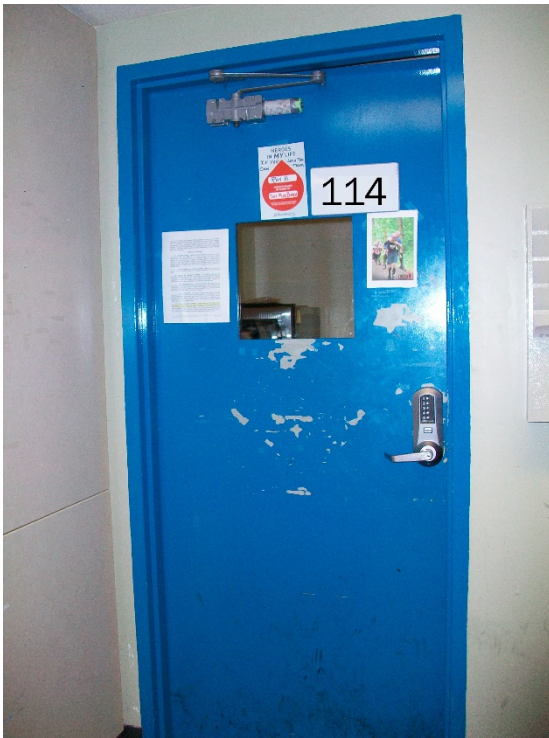
Figure 9.09: Door 114

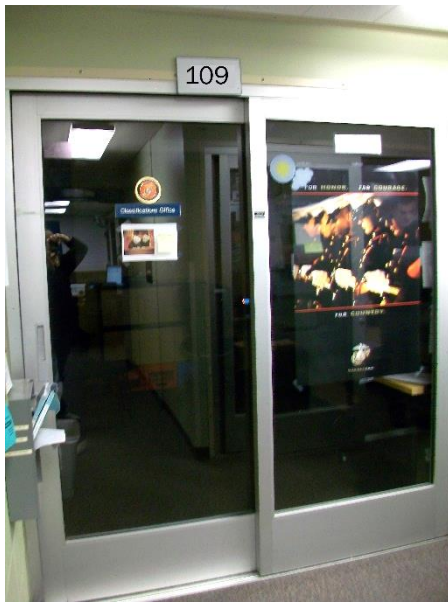
Figure 9.10: Sample of interior aluminum sliding door

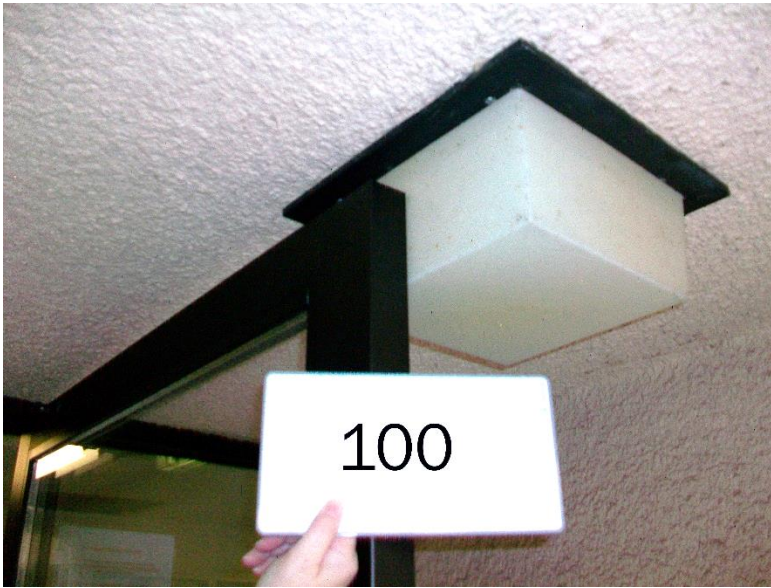
Figure 9.11: Door 100 hitting surface mounted light fixture

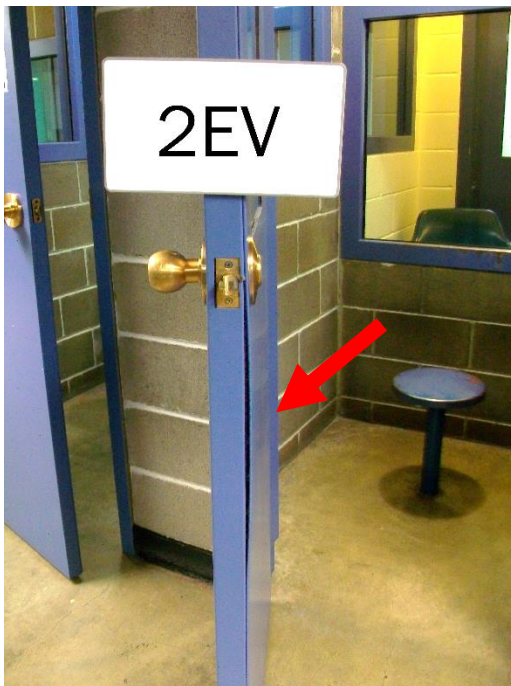
Figure 9.12: Door 2EV damaged door face

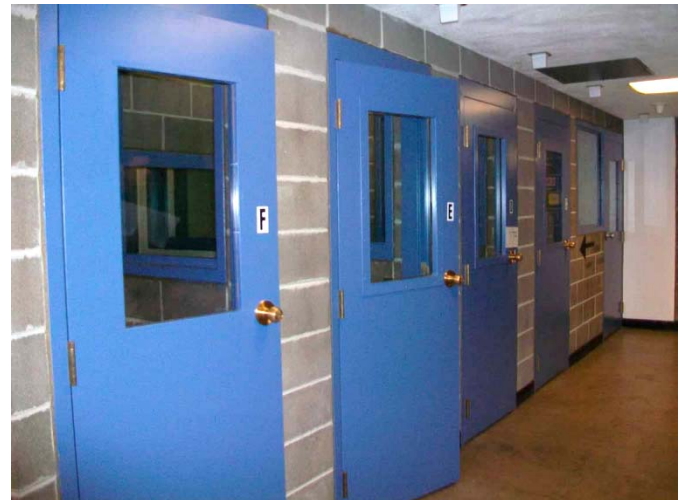
Figure 9.13: Looking towards inmate visitation doors

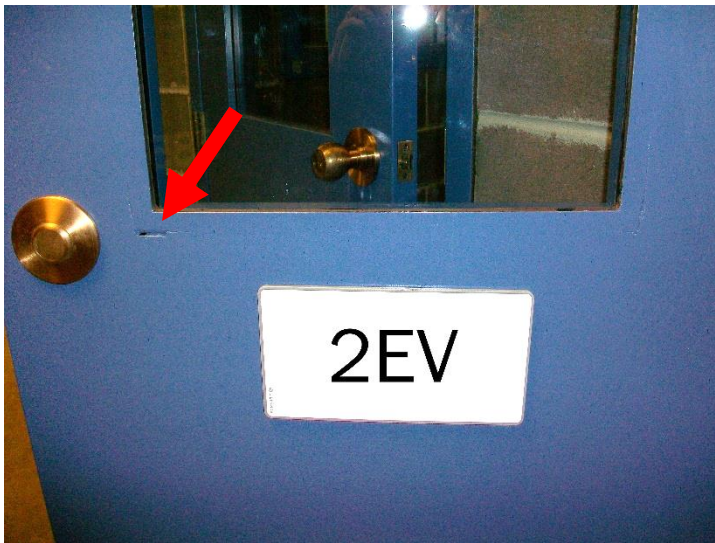
Figure 9.14: Door 2EV-Typical damage at vision lite frame

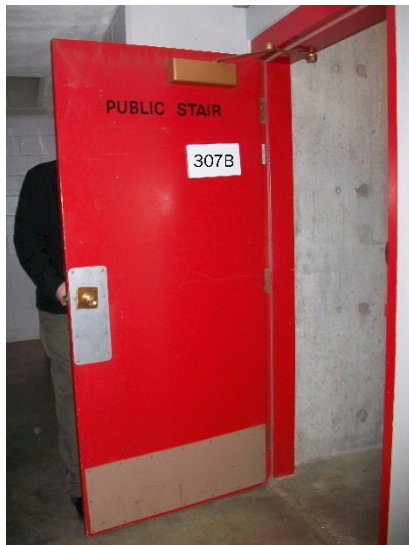
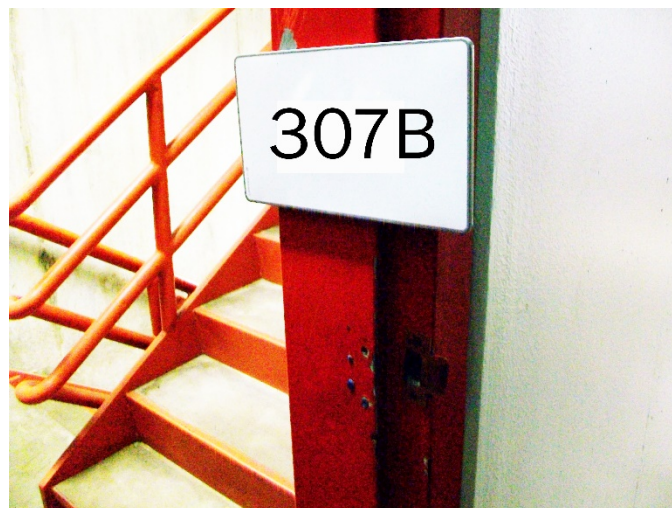
Figure 9.15: Door 307B knob hardware    Figure 9.16: Door 307B frame condition

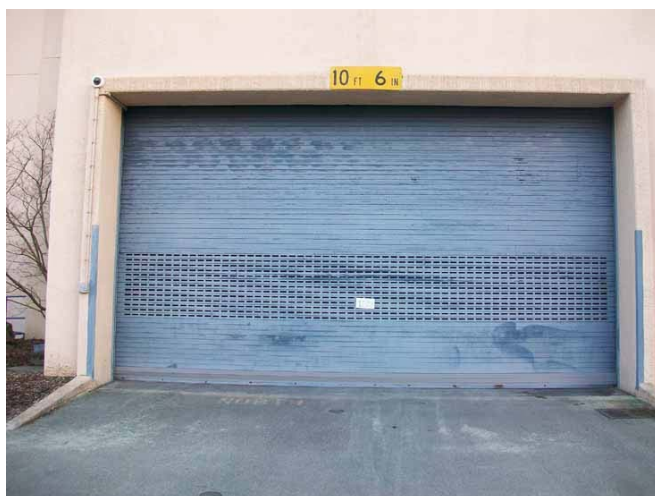
Figure 9.17: Standard condition of coiling doors

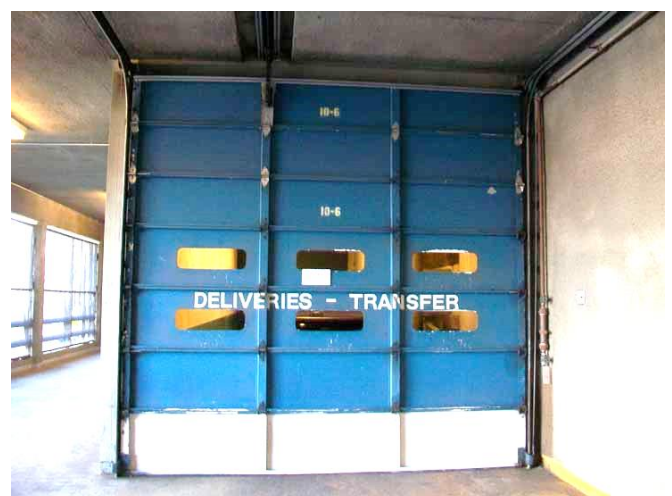
Figure 9.18: Condition of overhead panel door

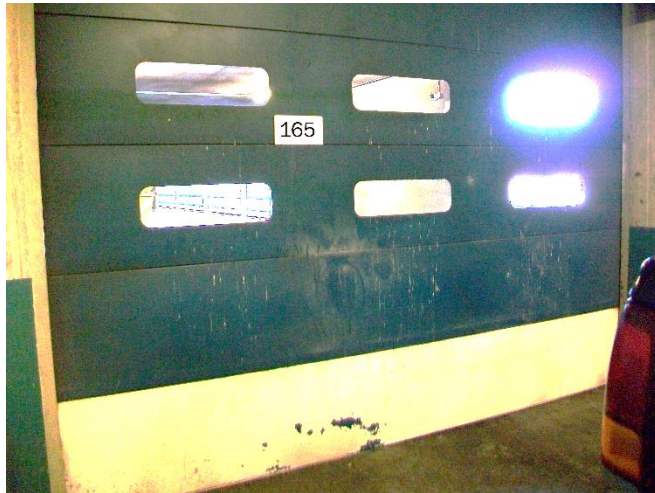
Figure 9.20: Damage at bottom door panels

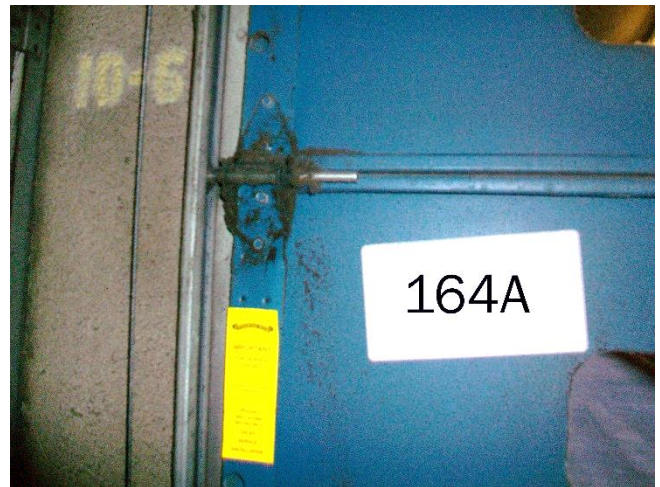
Figure 9.21: Lint accumulation on hardware

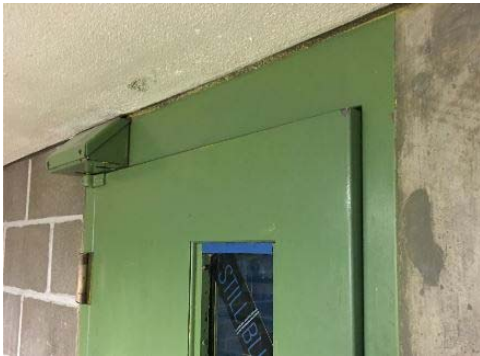
Figure 10.01: Warped Door

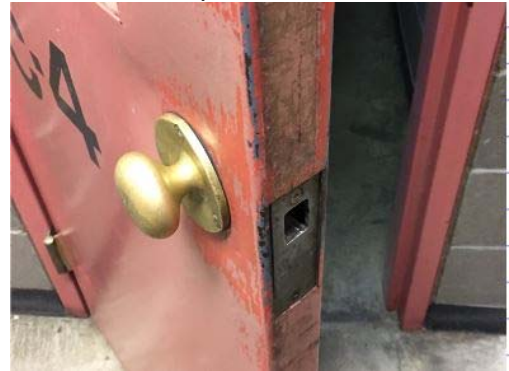
Figure 10.02: Denting at Door Knob/Door Bulging at strike plate

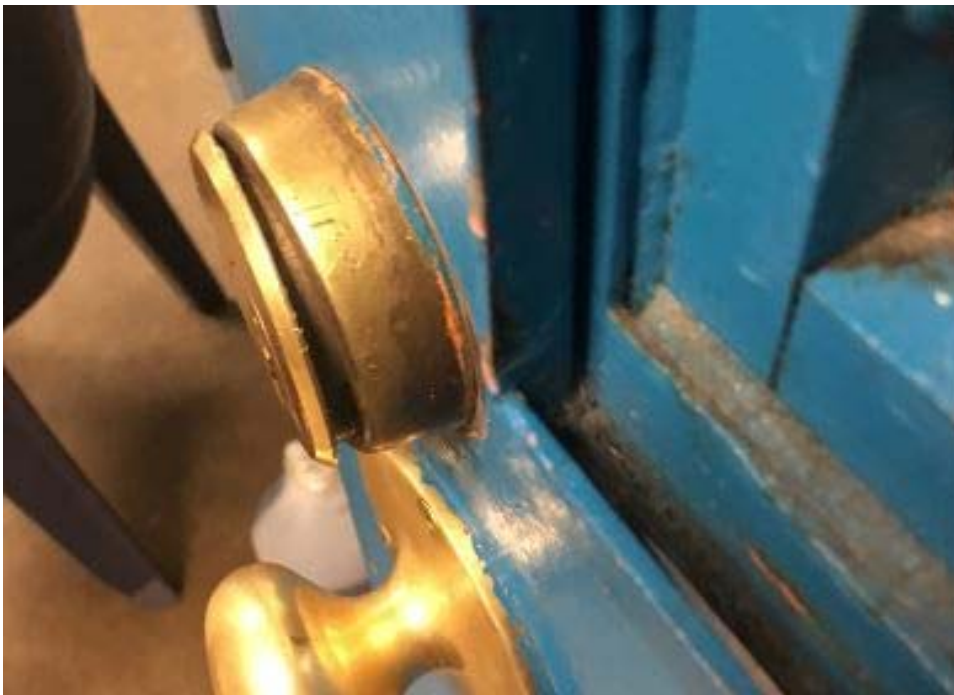
Figure 10.03: Damaged Mogul Lockset

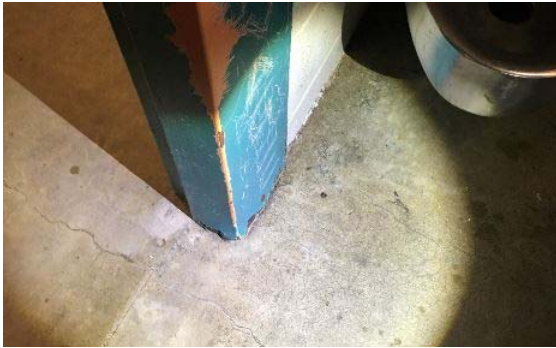
Figure 10.04: Rusted Frame at Base

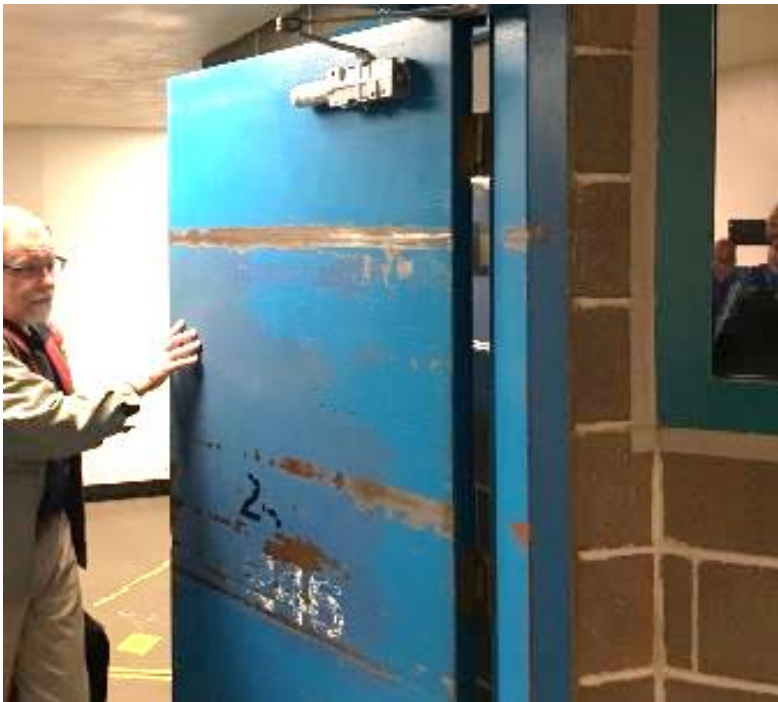
Figure 10.05: Paint Scraping

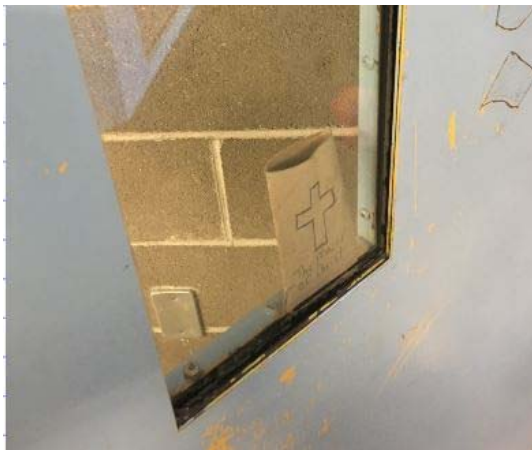
Figure 10.08: Glazing Stops Missing

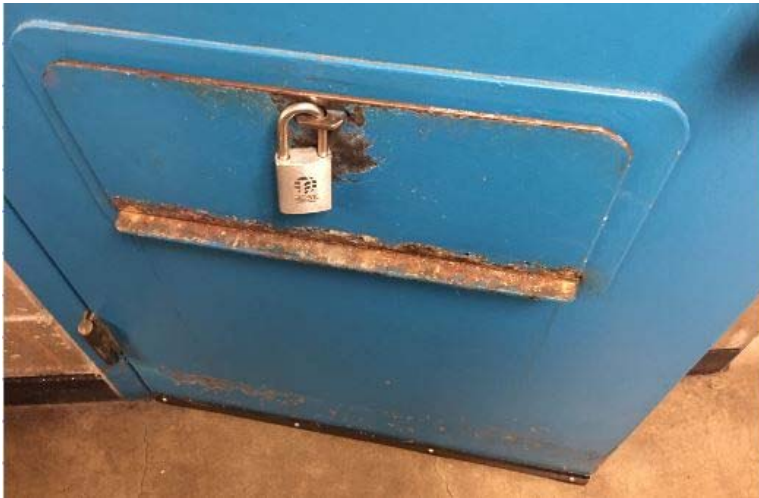
Figure 10.09: Rusted Cuff/Food Pass Port

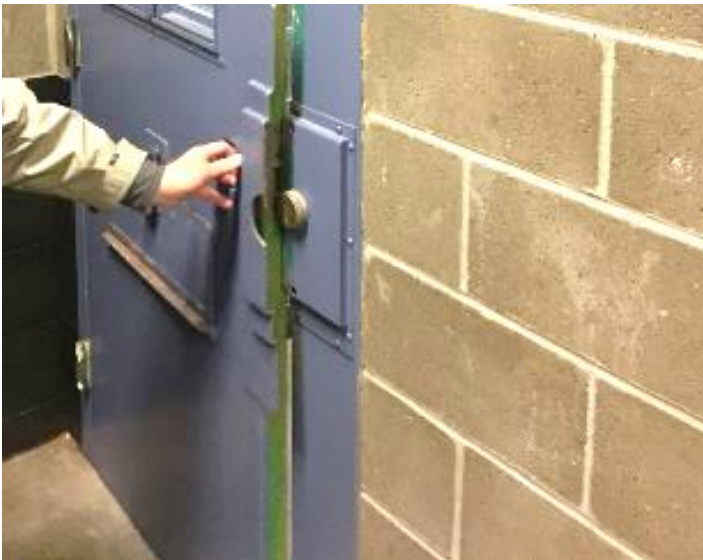
Figure 10.10: Recessed Hand Pull / Steel Cover Plate

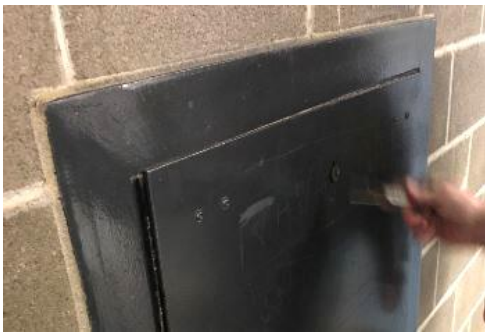
Figure 10.13: Bent Mechanical Chase Door

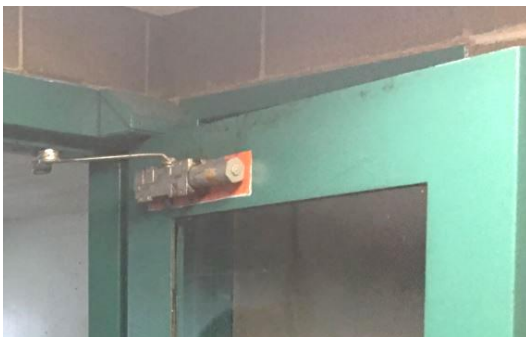
Figure 10.14: Door Closer Leaking Oil

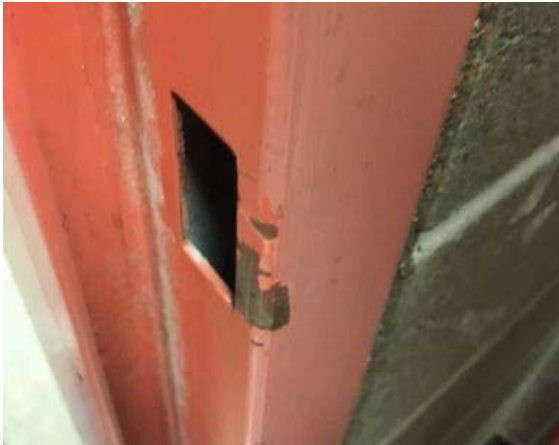
Figure 10.15: No Bolt Keeper/Hole in Door Frame Only

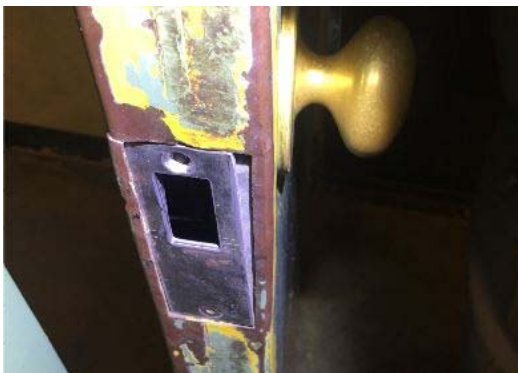
Figure 10.16: Screw Missing in Strikeplate/Door Frame

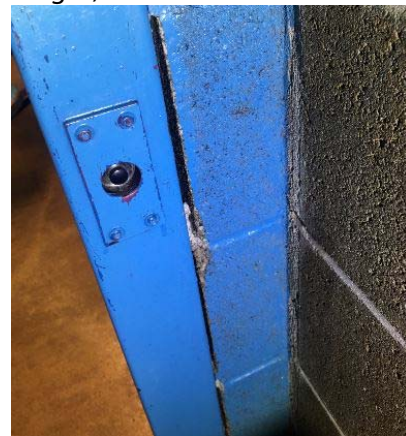
Figure 10.17: Missing Groove Bulging at Strikeplate

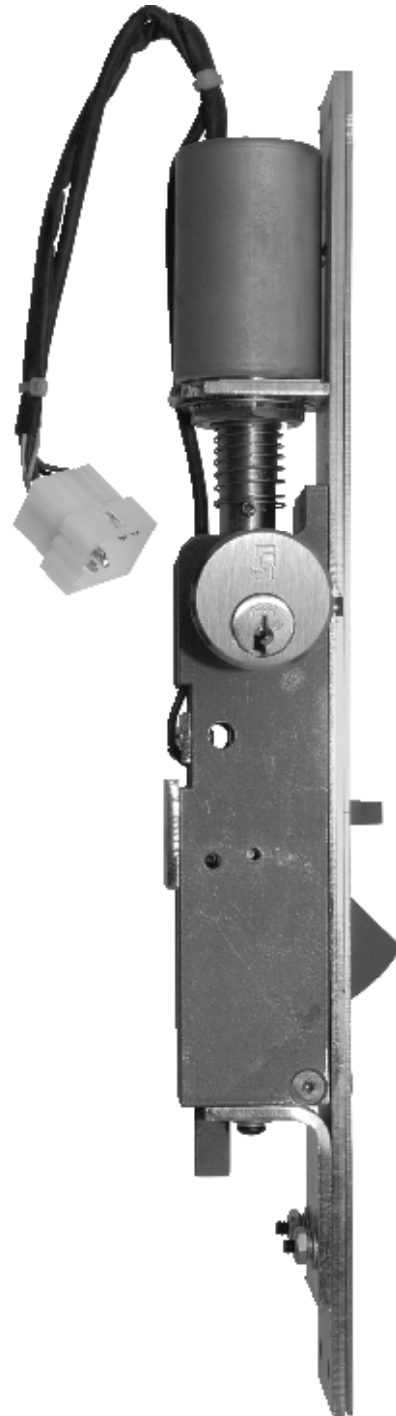
# JAMB MOUNTED FOR SWINGING DOORS

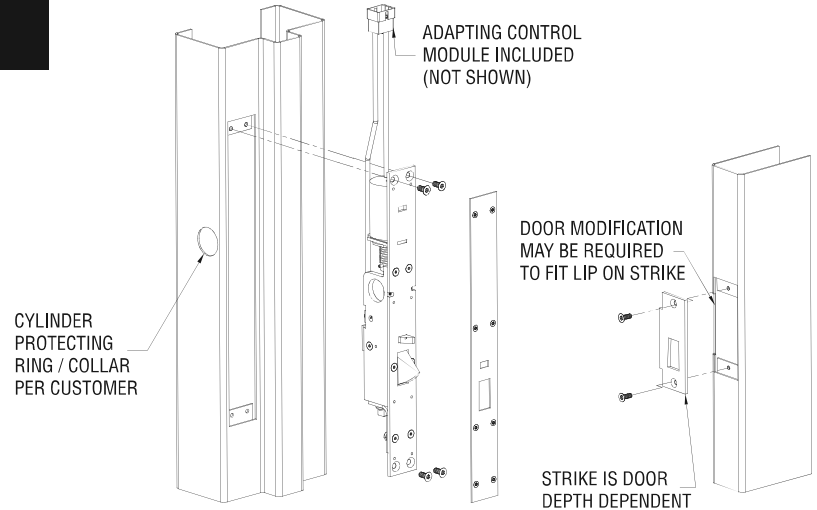
Strike is supplied with lip. Modifications for clearance may be required.

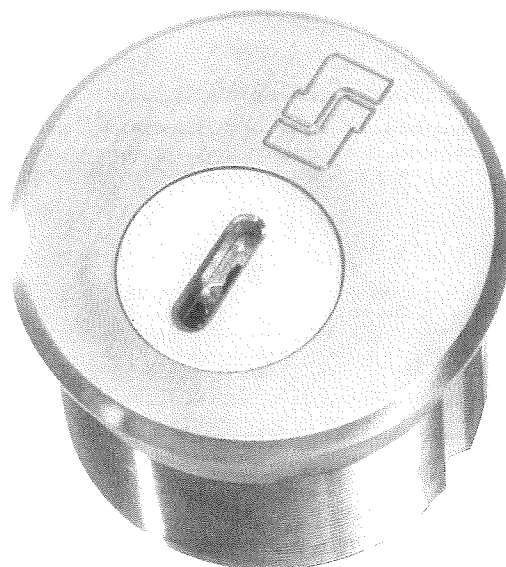
- STANDARD FINISH: US26D
- MOGUL CYLINDERS:  
Brass
- MOGUL KEYS: Nickel silver
- CYLINDER SIZE: 2" thread  
Diameter
- CYLINDER WEIGHT: 1.5 lbs.
- KEY SIZE: 2-3/8" L x 1/8" TK
- TENSILE STRENGTH:  
91,000 lbs/in.2
- YIELD STRENGTH:  
76,000 lbs/in.2
- ROCKWELL HARDNESS:  
84-86.5 HRB
- PIN TUMBLERS:  
Combination nickel silver  
and stainless steel,  
6 tumblers per lock

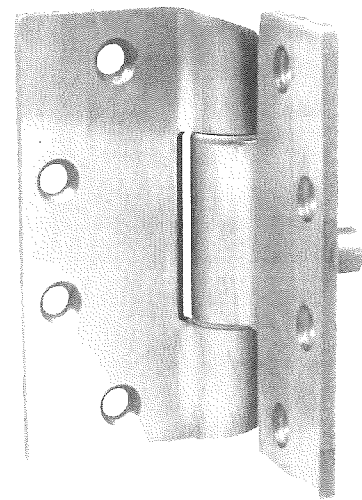
# 534 Door Position Switch

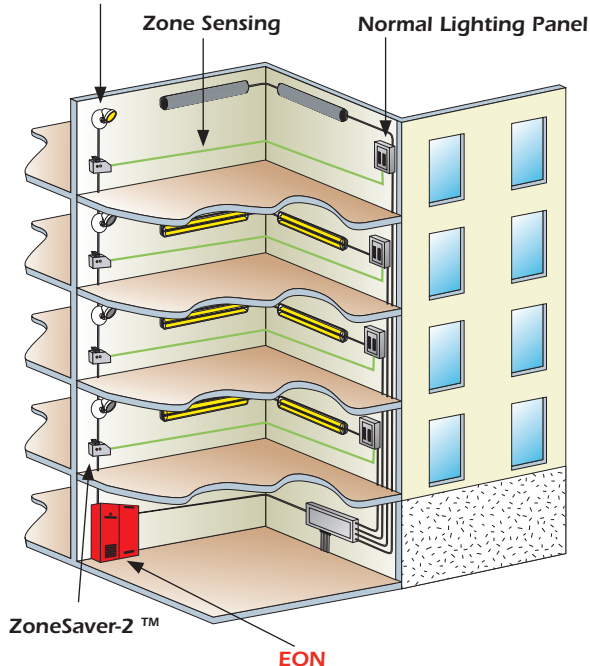
NOTES: For illustration purposes only; drawing not to scale.

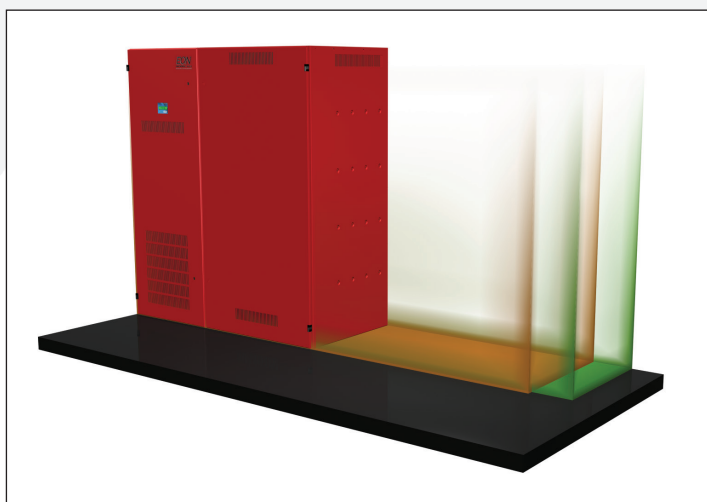
**Note:** Illustration depicts product without standard floor channels.

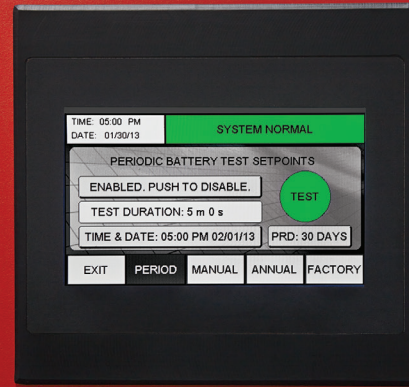
The color touchscreen display on the **Intellistat TS** provides all electrical parameters, inverter status, programmable inverter and battery testing, and data-logging. Optional **NetMinder™** communications allow for remote monitoring and reporting via **BACnet/IP** or **BACnet MS/TP**, **Ethernet TCP/IP**, **MODBUS TCP**, or **MODBUS RS485**. For more details, see the **Remote Communications** description on Page 7.

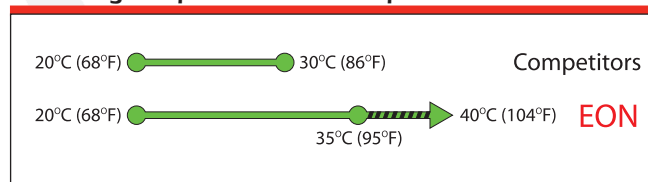
**NOTE:** To satisfy UL 924 requirements for a performed in a 40°C ambient environment, wit and at low line input voltage.

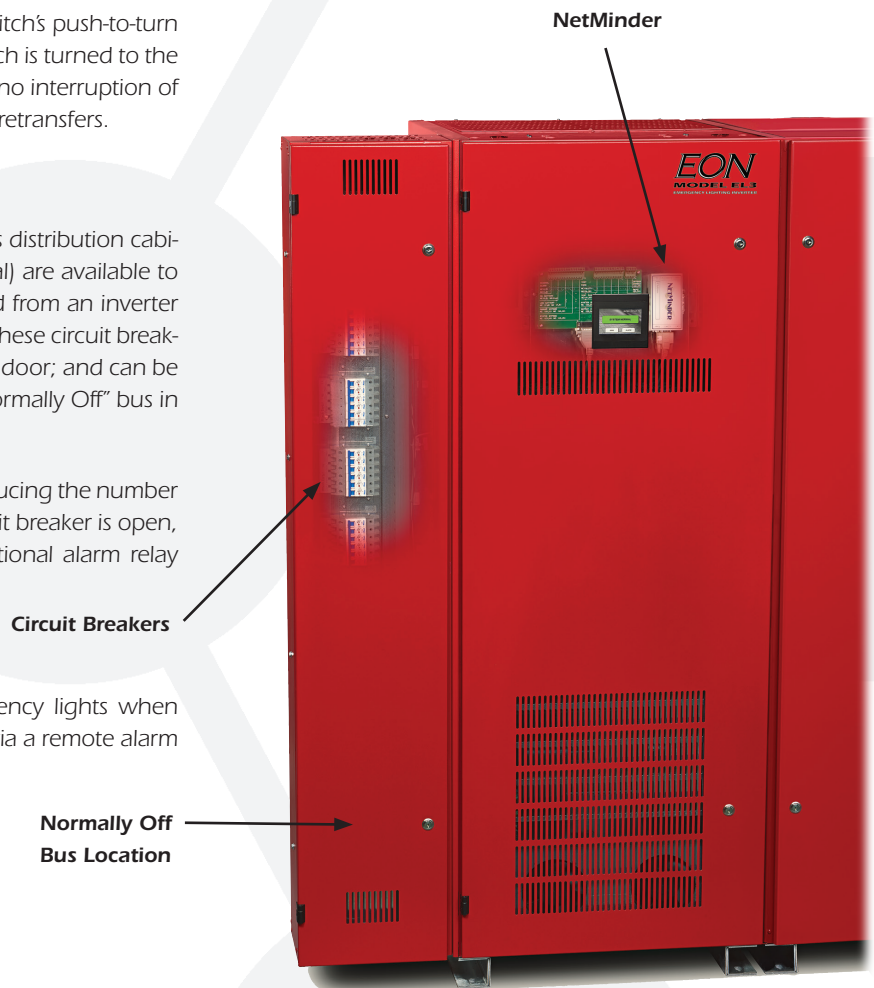
The **EON's Intellistat TS** monitor is available with optional **NetMinder** communications. **NetMinder** integrates the **EON** into a BACnet/IP or BACnet MS/TP, Ethernet TCP/IP, MODBUS TCP, or MODBUS RS485 network with a specific IP address for Ethernet connected systems. **NetMinder** provides remote monitoring of the inverter status, battery test pass/fail results, alarm conditions, and electrical measurements via a web browser, without the need for any external software. Remote notification of alarms and status are available via SNMP, e-mail, and network broadcast messaging, or the user's building management system.
