**Building Assessment Studies and Cost Estimates**  
for  
**Capital Improvements**  
at the  
**Jail (Public Safety Building)**

Whatcom County - Contract 201607005 – PHASE 1B

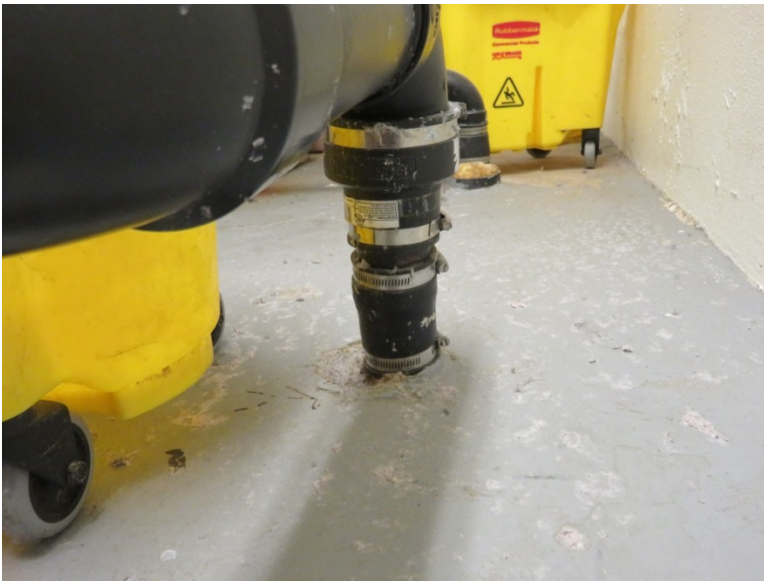
- b) Repair/replace the drain connection for the older clothes washer to eliminate the existing leak visible in the drain room (see Figure 17.10 through 17.12).
  - i) Extend new drain pipe from the floor penetration to the existing indirect drain (approximately 15ft of pipe and 3 elbows).

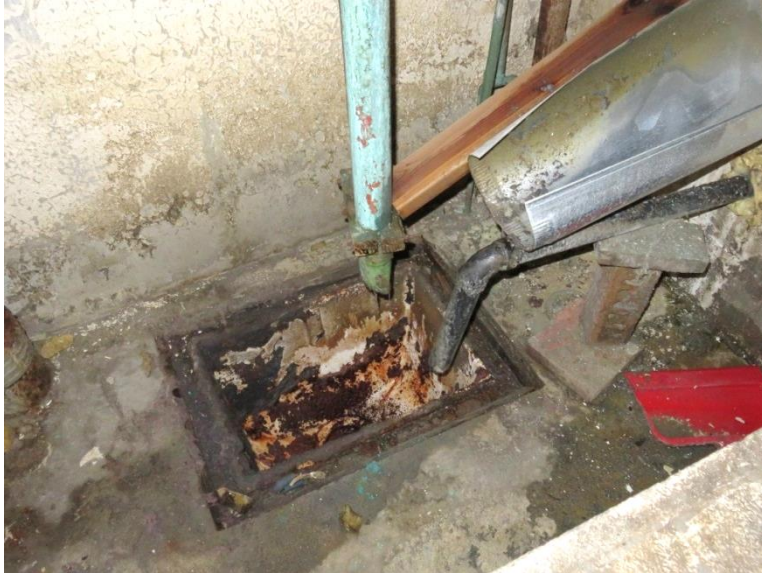
Figure 17.11: Older clothes washer drain leak damage (Basement Floor) inside the drain room

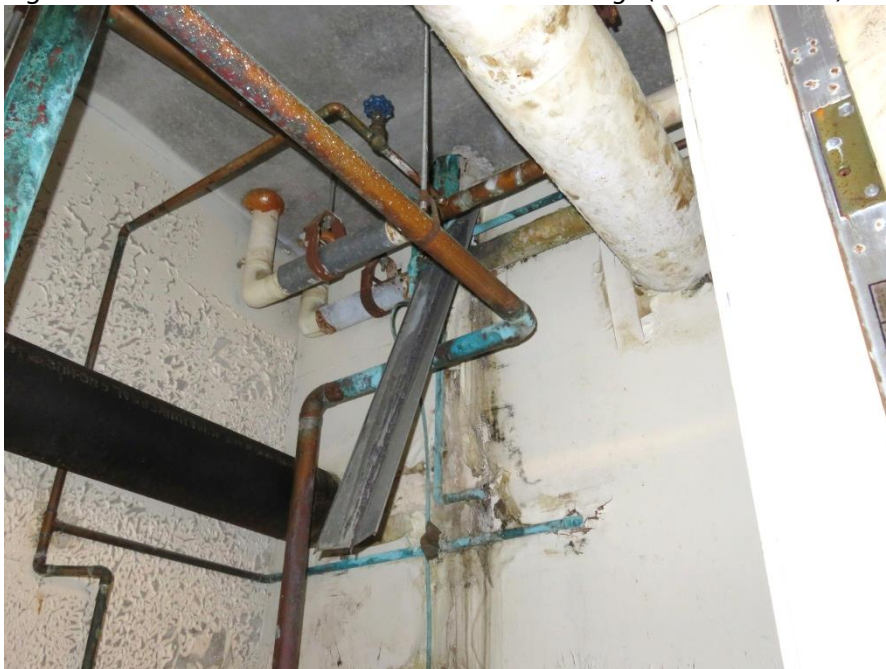
Figure 17.12: New clothes washer drain leak damage ( Basement Floor) inside the drain room

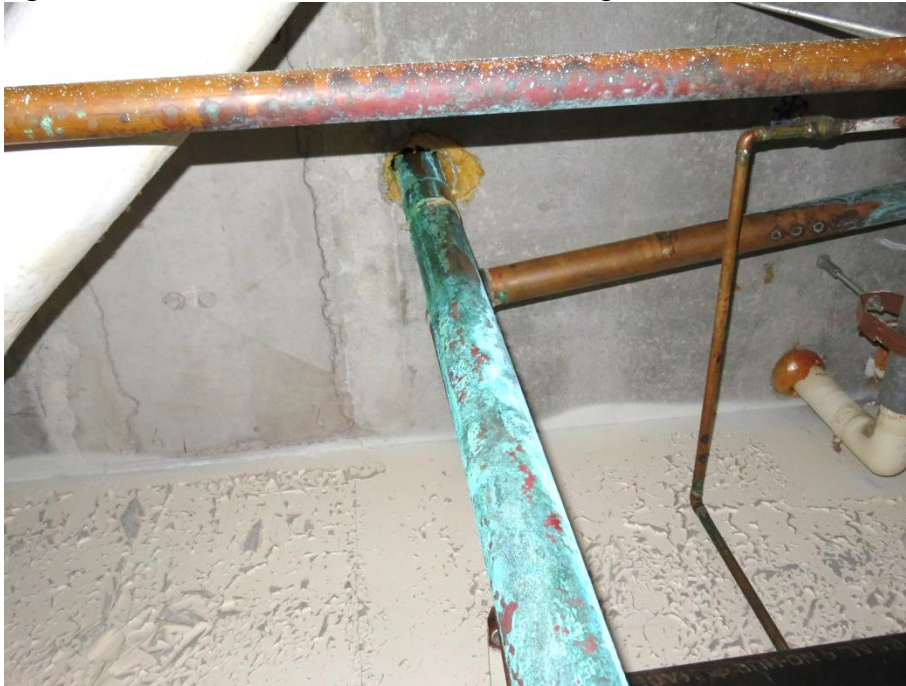
- c) Provide exhaust air service to the drain room (refer to drawing M17.05.01).
  - i) Measure the existing airflow in the existing exhaust ductwork in the storage room.
  - ii) Extend a new 6" round ductwork from existing exhaust system in the storage room to the drain room (approximately 22ft of duct and 3 elbows).
  - iii) Adjust fan sheaves and pulleys as required to reestablish existing airflow downstream of new 6" duct connection and to establish 100cfm of exhaust at the new drain room.
- d) Clean the inside of the room to remove chemical residue and any mold that exists.
